# **Arboricultural Impact Assessment**

### **Como Baptist church**

109, 111 & 113 Robert Street 469 & 471 Canning Highway Como, Western Australia

Commissioned by: DEM (Aust) Pty Ltd

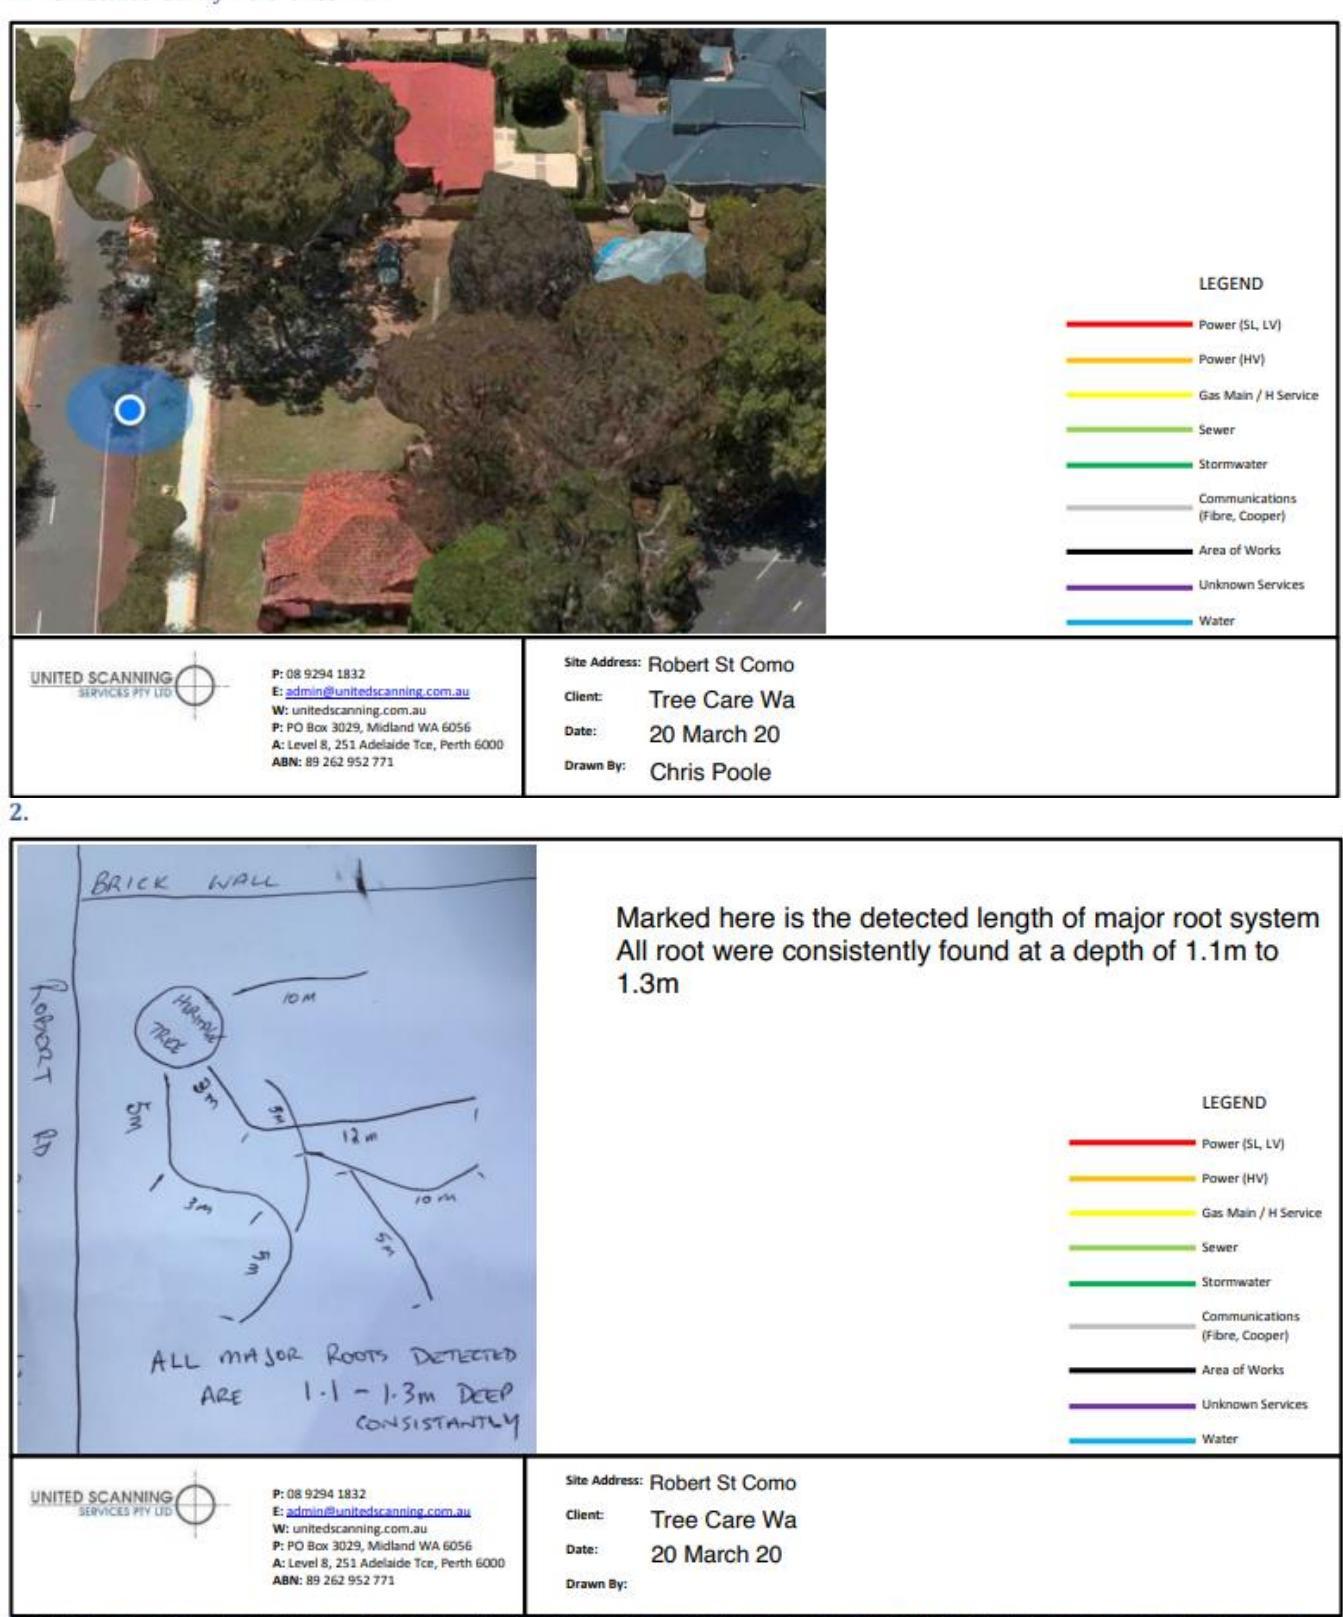
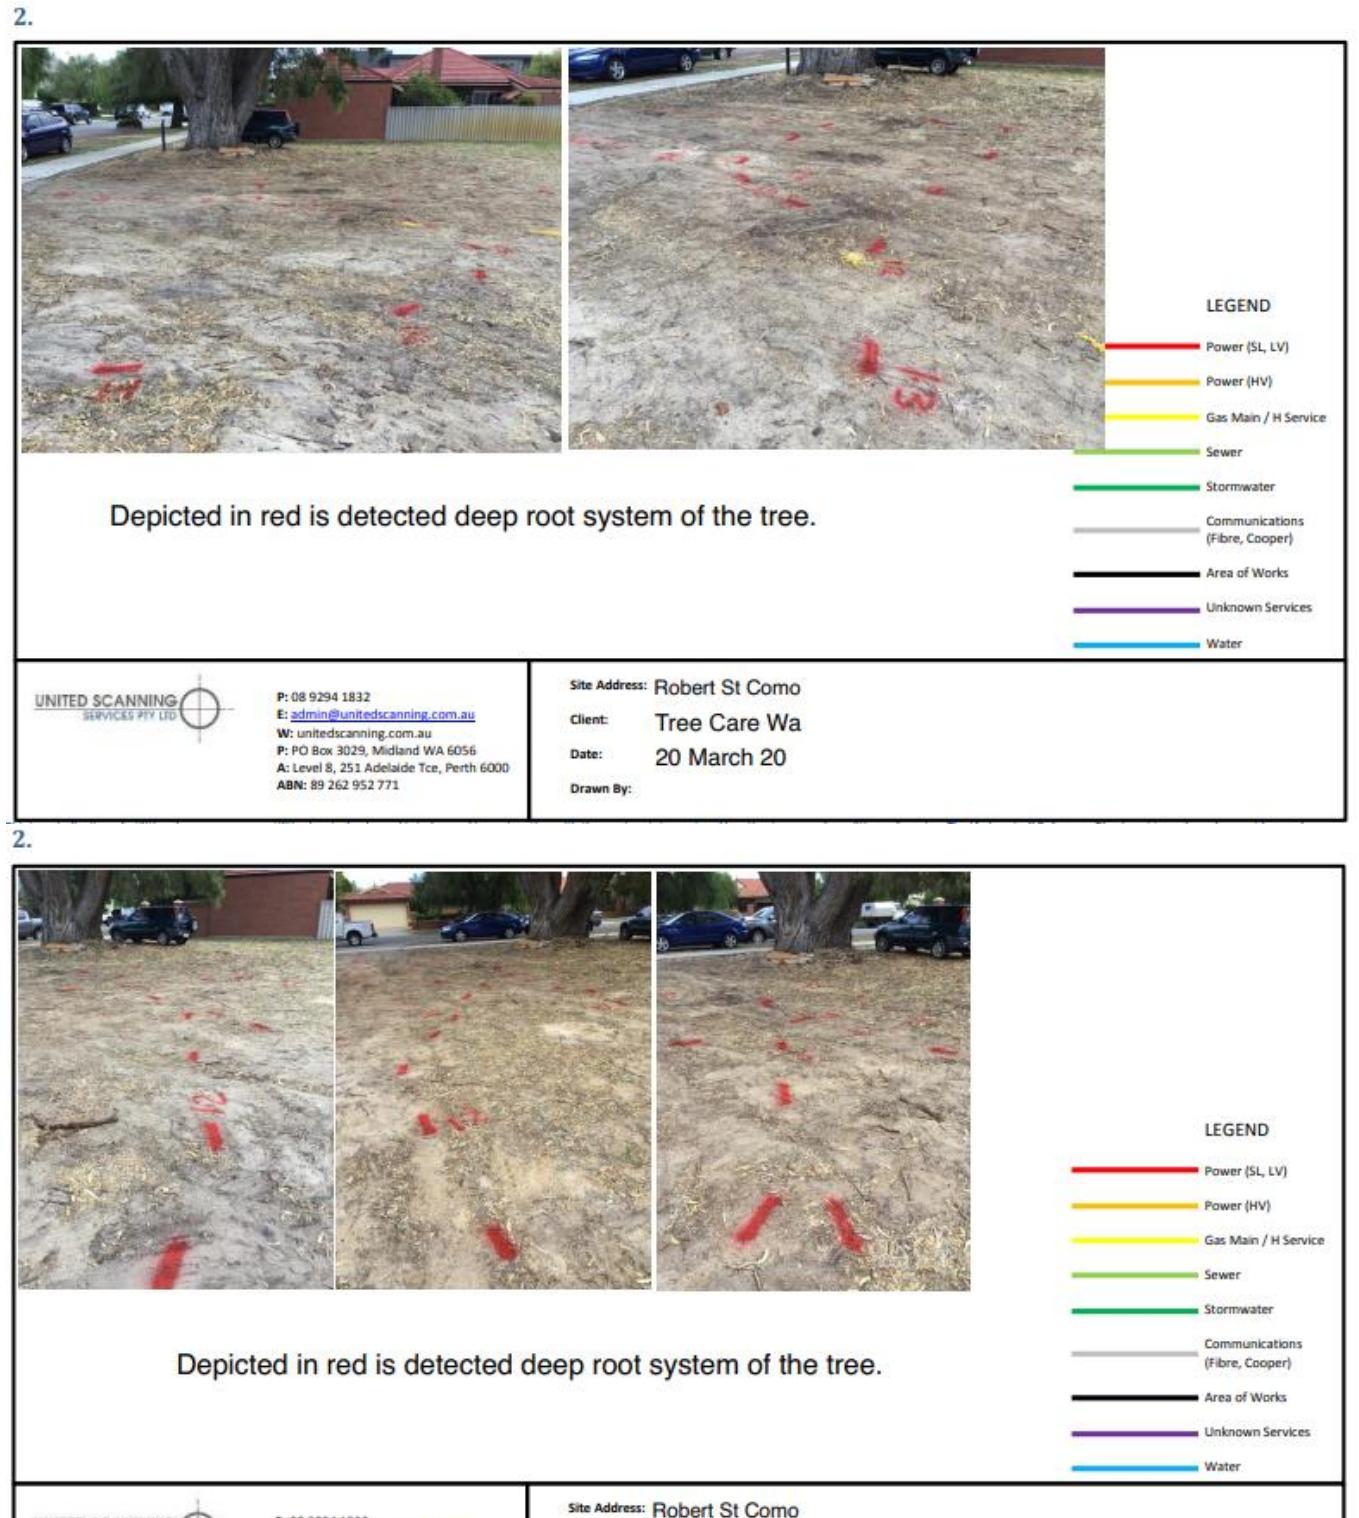
Arboricultural Impact assessment - 109, 111 & 113 Robert Street and 469 & 471 Canning Highway Como. July 29<sup>th</sup>, 2020. Rev 2 March 8<sup>th</sup>, 2021. **2.** As Located Utility Reference Plan

Undertook GPR scanning to map out major tree root system on a heritage listed tree. All detected roots are marked clearly on site with approximate depths.

- All works to be completed in conjunction with the attached Tree Protection Plan (TPP)
- Root pruning for tree 222 is to be completed by the project Arborist utilising non- destructive detection methods in accordance with AS4372-2007 Pruning of Amenity Trees using clean sharp hand tools.
- All trees to remain will require tree protection methods as per AS4970 2009 Protection of trees on development sites.
- Following the sites demolition, reduce the TPZ fencing surrounding Tree 222 to accommodate excavation for the footings.
- Ground protection system must be installed and maintained for the developments duration in accordance with AS4970-2009 Protection of Trees on Development Sites. The ground protection system can only be removed once the dwellings construction has ended to allow for landscaping.

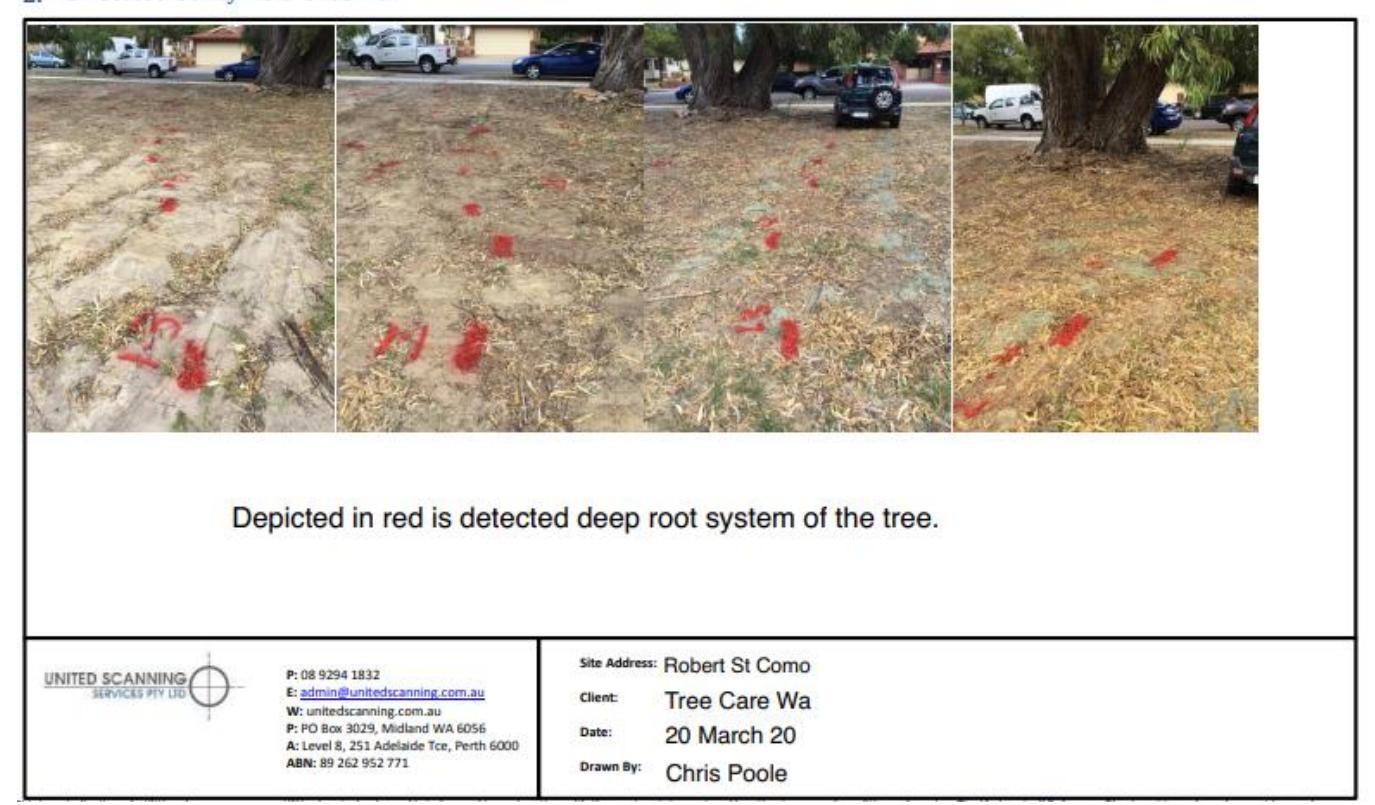
Arboricultural Impact assessment - 109, 111 & 113 Robert Street and 469 & 471 Canning Highway Como. July 29<sup>th</sup>, 2020. Rev 2 March 8<sup>th</sup>, 2021. 2. As Located Utility Reference Plan

Tree 222 - The basement of the proposed north western building will make an encroachment of 125m<sup>2</sup> into the TPZ of the tree with no SRZ incursion. This encroachment represents 17.8% of the total TPZ area which is 706.9m<sup>2</sup>. This is unlikely to affect the health and structural integrity of the tree providing that the tree protection plan is enforced.

A root mapping exercise assisted with evaluating the risk to the tree prior the development application. There will be the need for stringent tree protection measures for tree 222 which is detailed within the tree protection plan. Root pruning at the extremity of the complex will be required to take place prior the development commences utilising the use of non-destructive trenching methods I.e. Vacuum excavation.
