Lot 4131 Smiths Beach Road, Yallingup Urban Water Management Plan

December 2021

Client: Smiths 2014 Pty Ltd

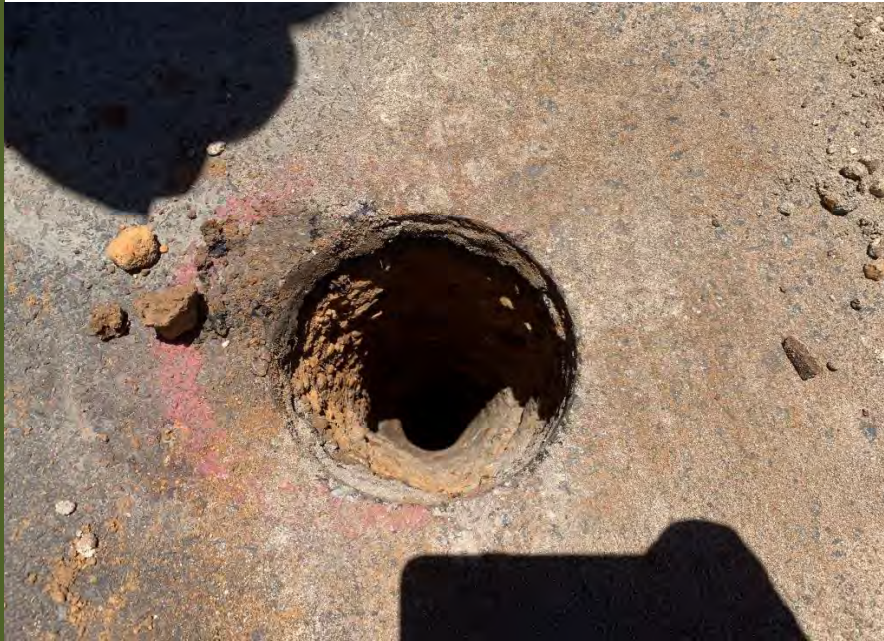
End of Hole (mm)	870					
Surfacing	ASPHALT 14 mm DGA	1 x DS				
Thickness (mm)	30					
Comments	cored with water					
Basecourse	Sandy GRAVEL/Gravelly SAND (GP/SP) fine to medium grained, sub-rounded to sub-angular gravel, brown, fine to coarse grained sand, trace fines	1 x DS				
Thickness (mm)	230					
Comments	dry					
Subgrade	SAND (SP) fine to coarse, pale brown, with fine to medium, sub-rounded gravel, trace fines different subgrade material from approx. 500 mm depth - Clayey SAND (SC), fine to coarse, low plasticity clay	1 x DS				
Comments	dry to moist					
Pavement Conditions and General Comments	Asphalt surfacing looks relatively new. Shape of pavement is good, no significant defects observed.

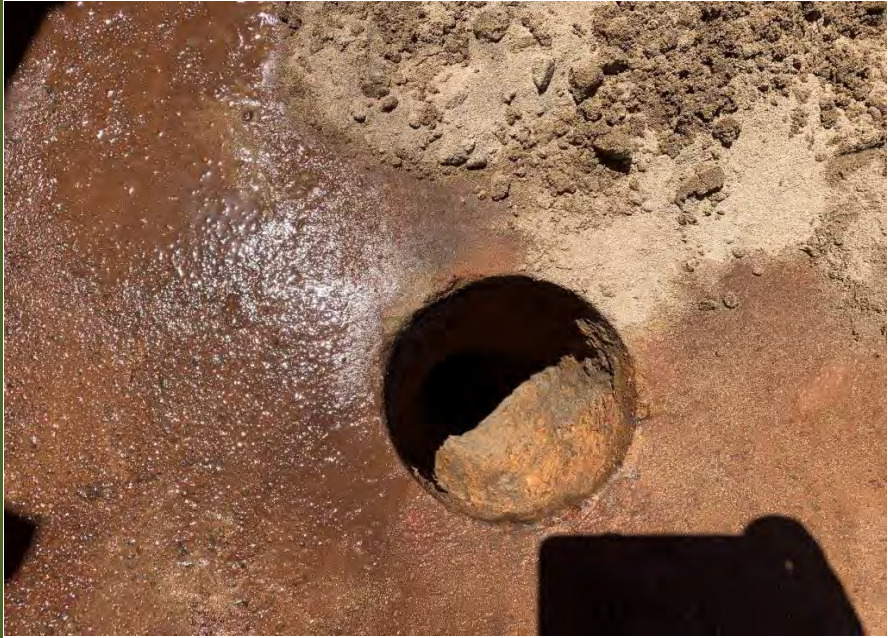
End of Hole (mm)		750												
Surfacing		ASPHALT 10 mm red laterite DGA with inferred 5 mm seal												
Thickness (mm)		30												
Comments		cored with water												
Basecourse		Clayey Sandy GRAVEL (GP-GC) fine to coarse grained, sub-rounded to sub-angular, brown, approximately 30% fine to coarse grained sand, low plasticity fines				1 x DS								
Thickness (mm)		260												
Comments		dry												
Subgrade		SAND (SP) fine to medium, brown to pale brown, trace non plastic fines				1 x BDS								
Comments		dry												
Pavement Conditions and General Comments		Asphalt surfacing looks relatively new. Shape of pavement is good, no significant defects observed. Minor flushing on the wheel paths closer to the bend - inferred due to turning stresses.

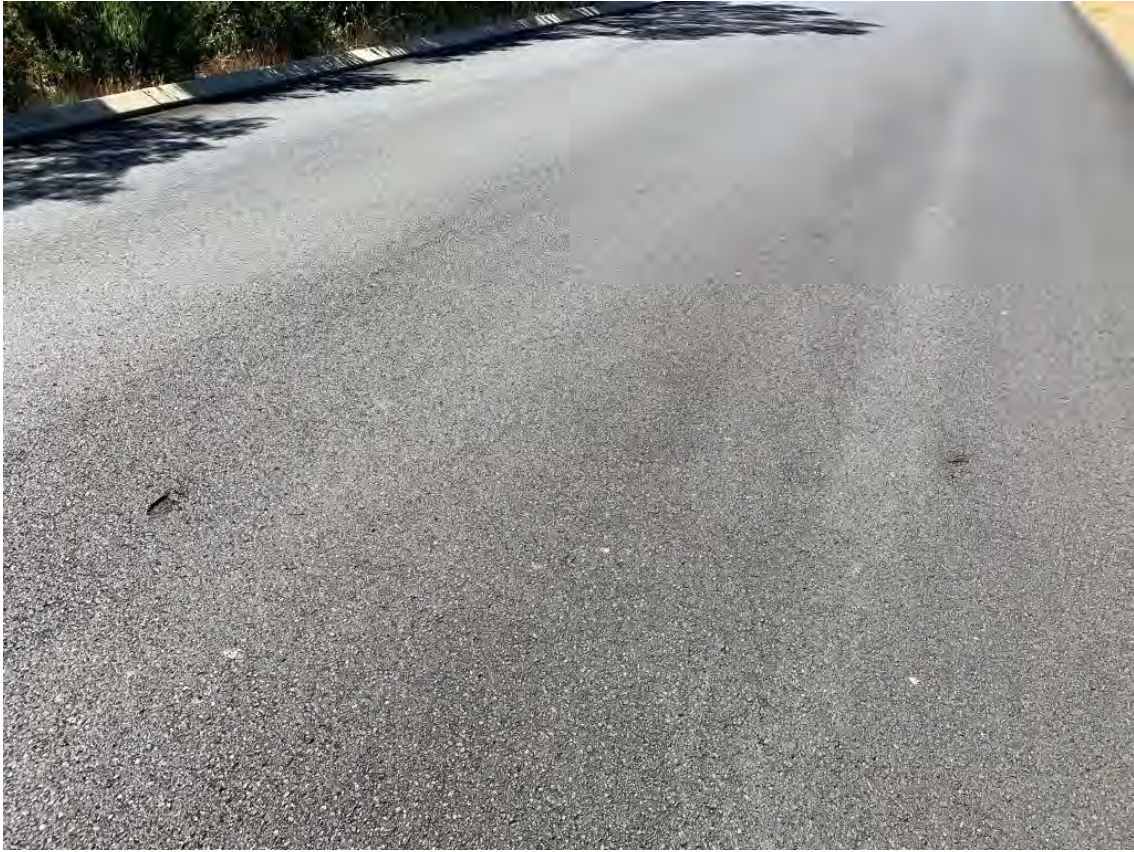
Minor potholes on the outer wheel path and outside of the inner wheel path of the northbound lane (approx. 210 m north of the intersection with Canal Rocks Road)

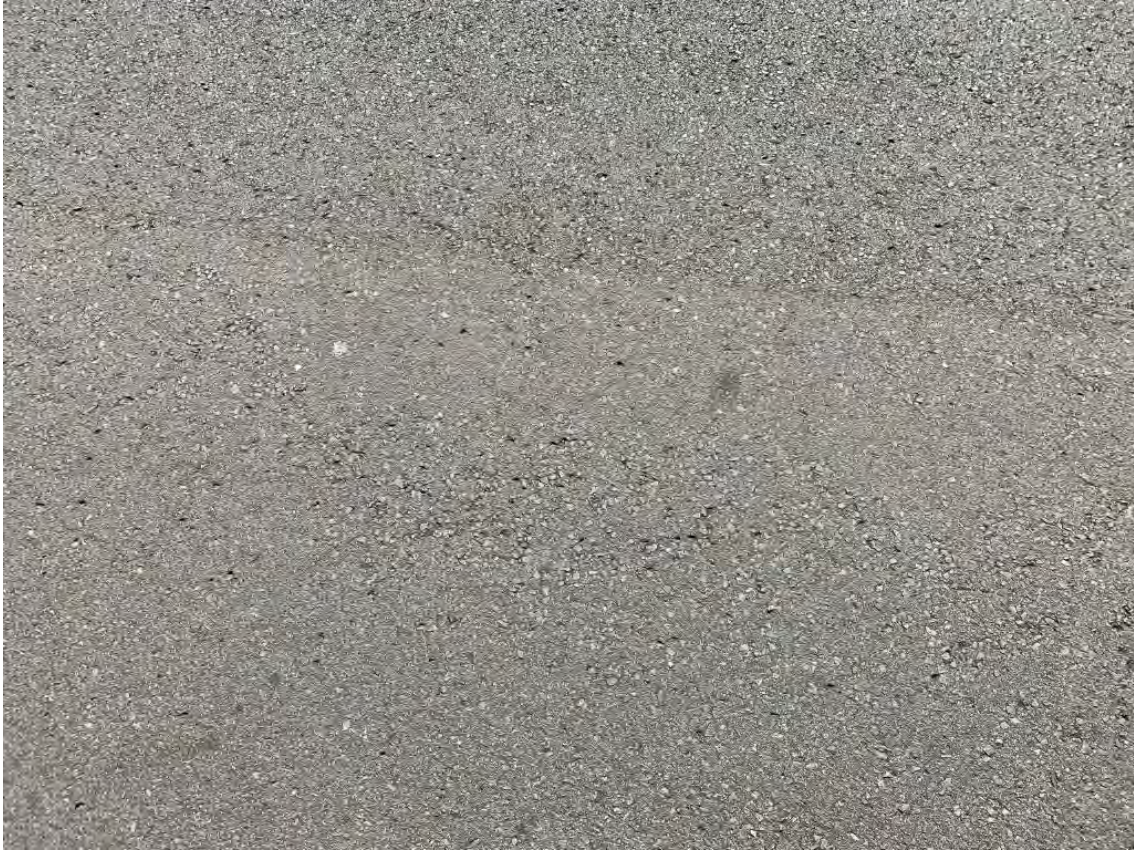
Observed minor to moderate ravelling in both lanes, pinhole defects suggest that aggregate have been plucked out by the traffic movement. As the asphalt looks relatively new (inferred age around 2 years), the early ravelling may have been caused by temperature of the mix/temperature during construction.

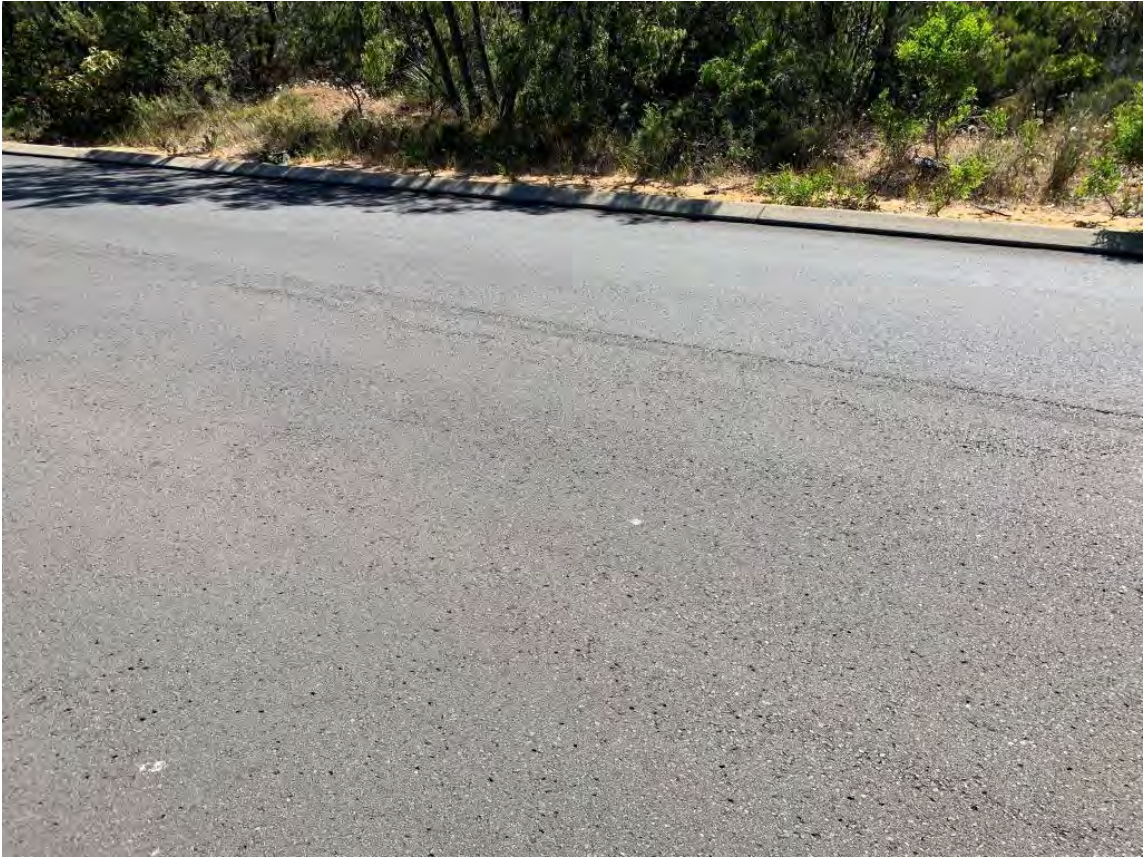
Minor ravelling along the longitudinal joint, could be due to construction practices. Pinholes observed across both lanes.

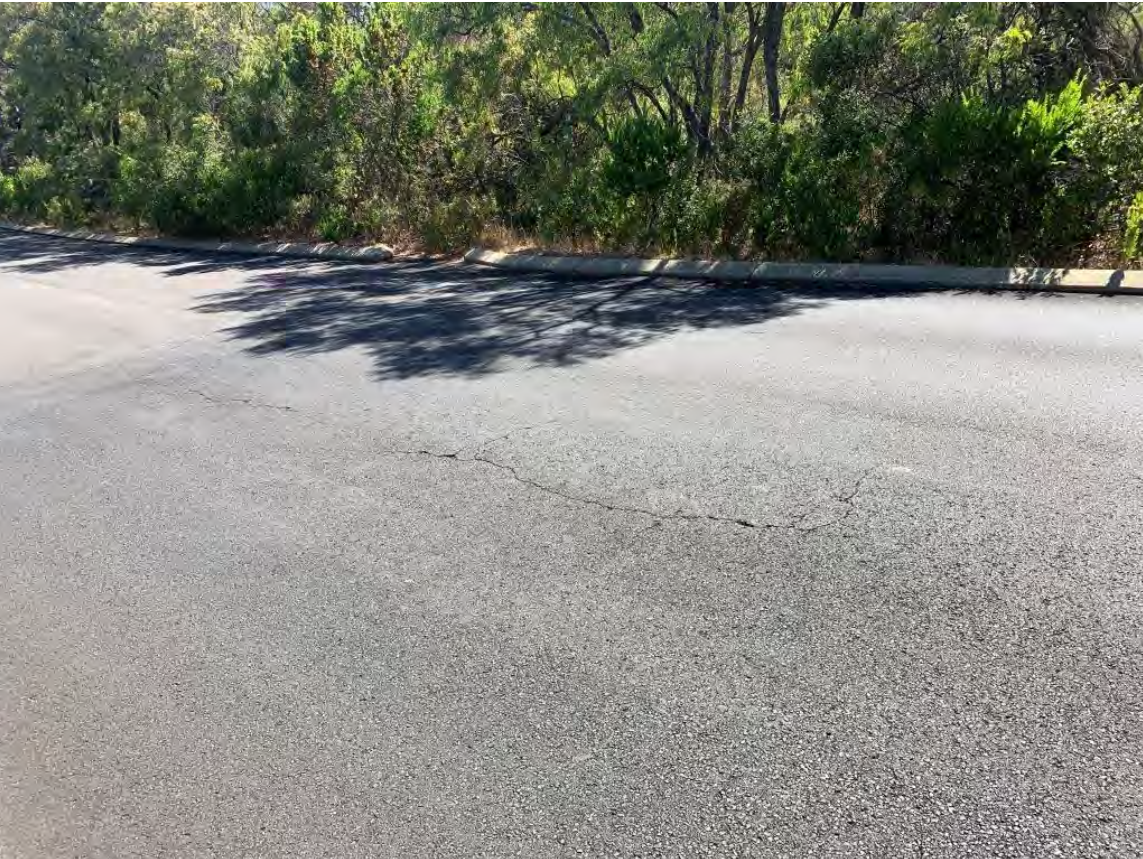
Longitudinal and transverse cracking between the two lanes

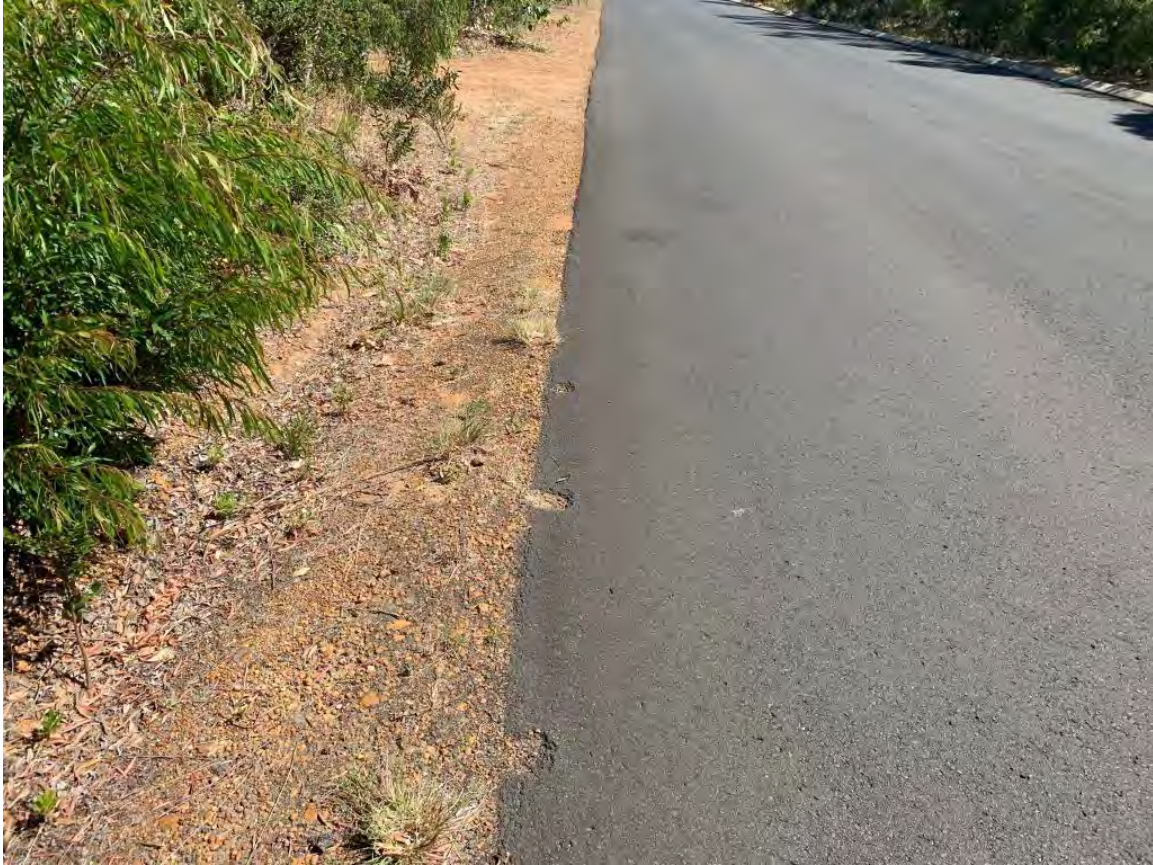
Small localised potholes along the edge of pavement (associated with edge break)

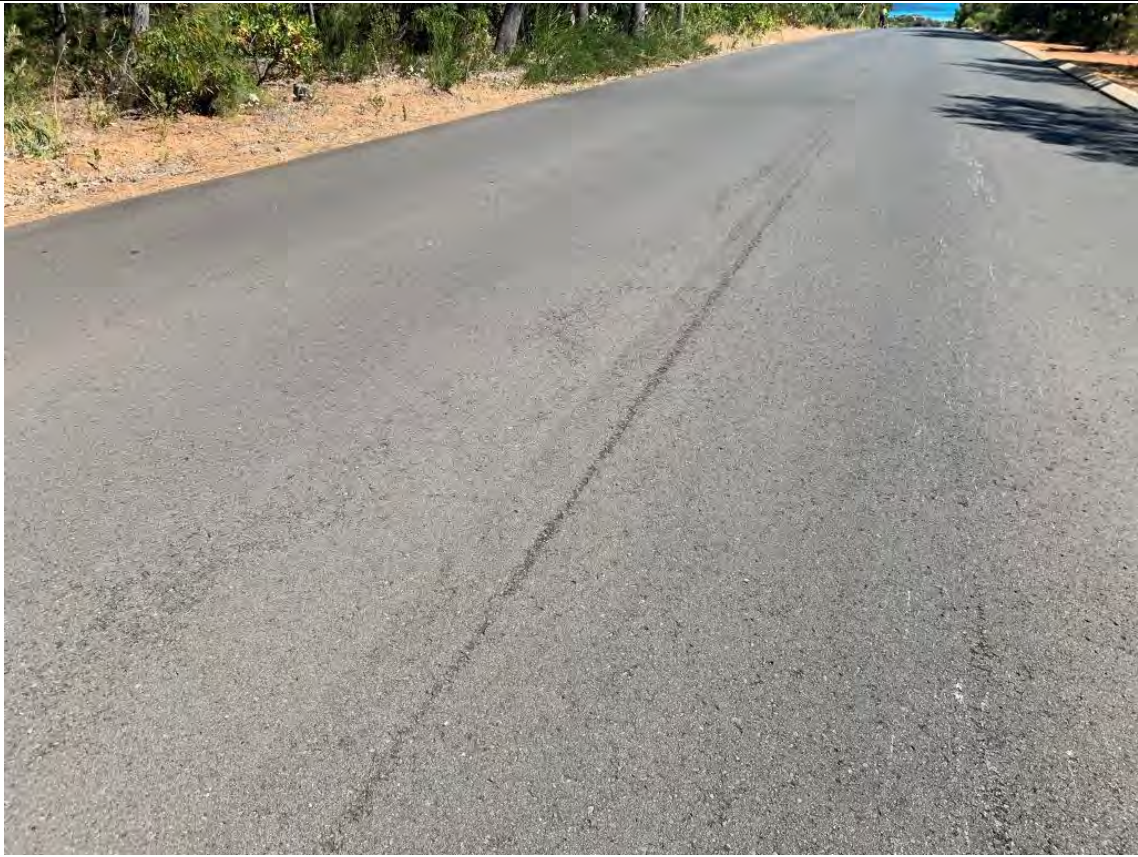
Observed minor ravelling outside the wheel path and along the joint on the northbound lane.

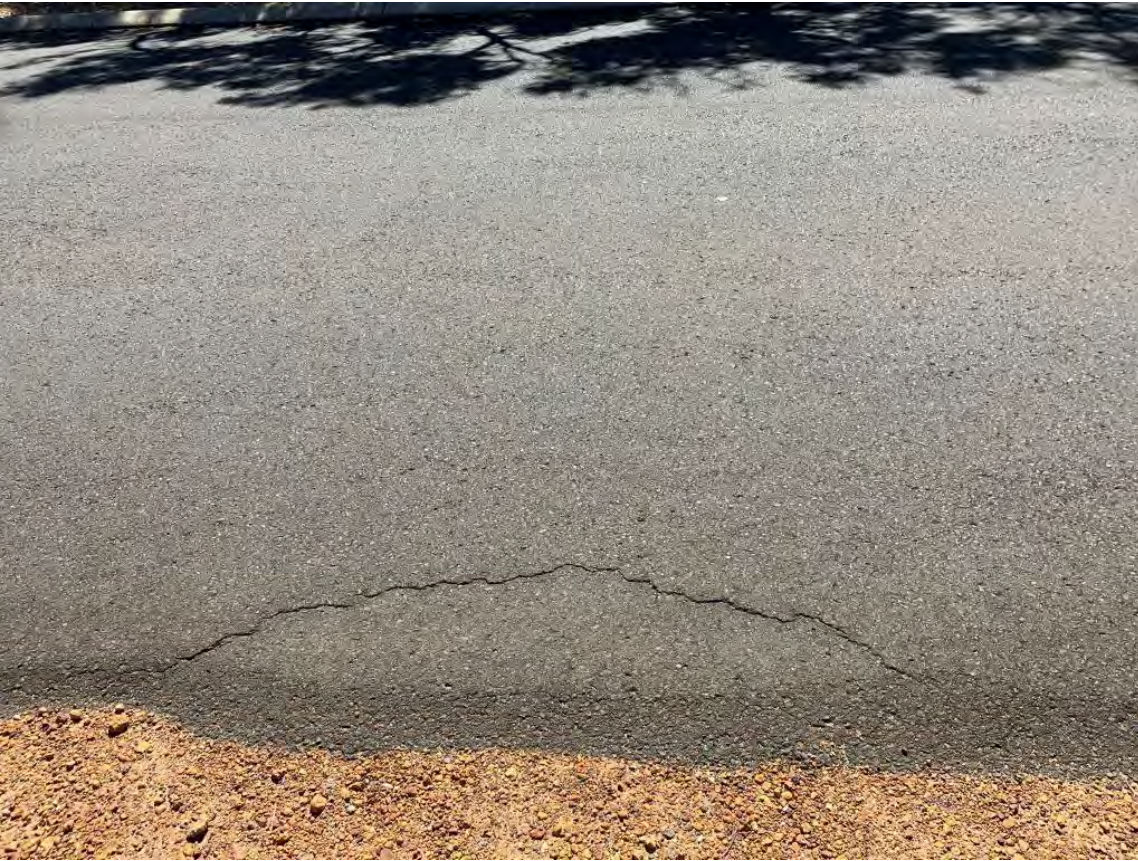
Longitudinal crack along the edge of pavement at localised areas

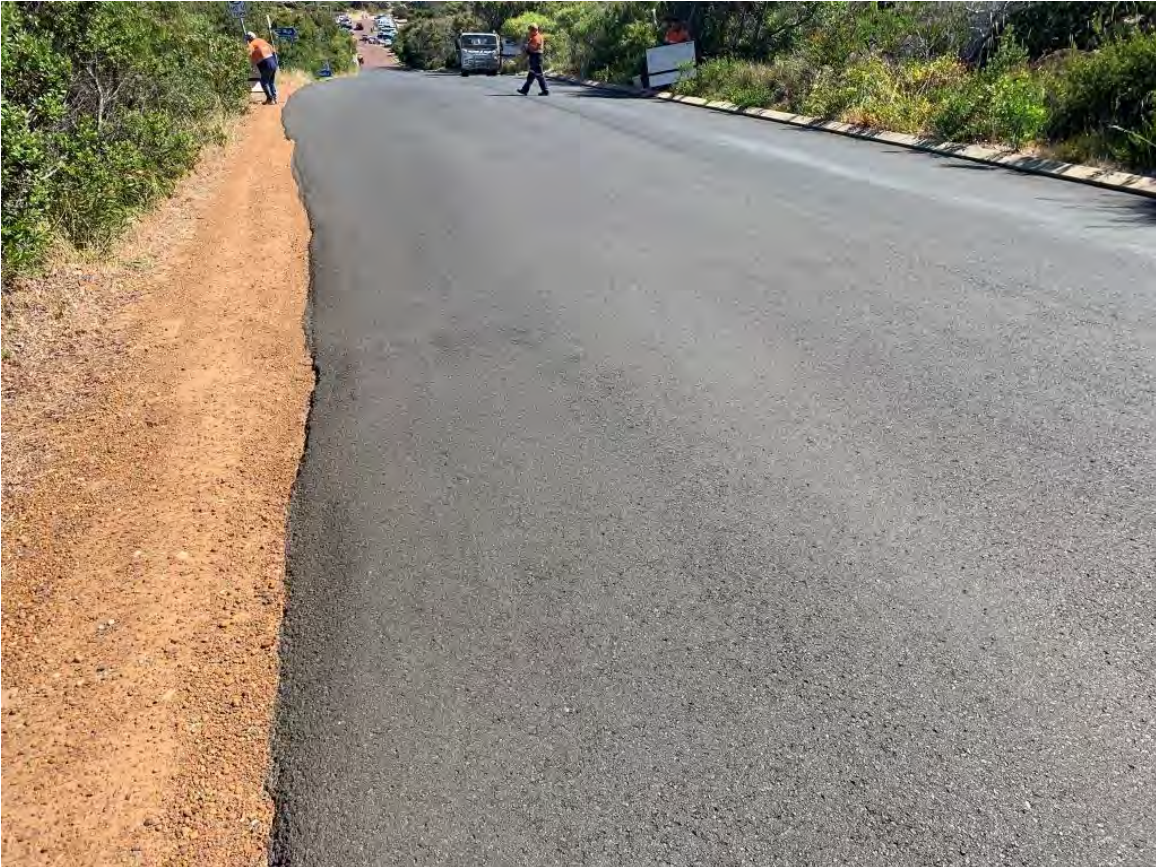
<p>Pavement shape along the investigated extent of road is good, no crocodile cracking or rutting observed.</p>

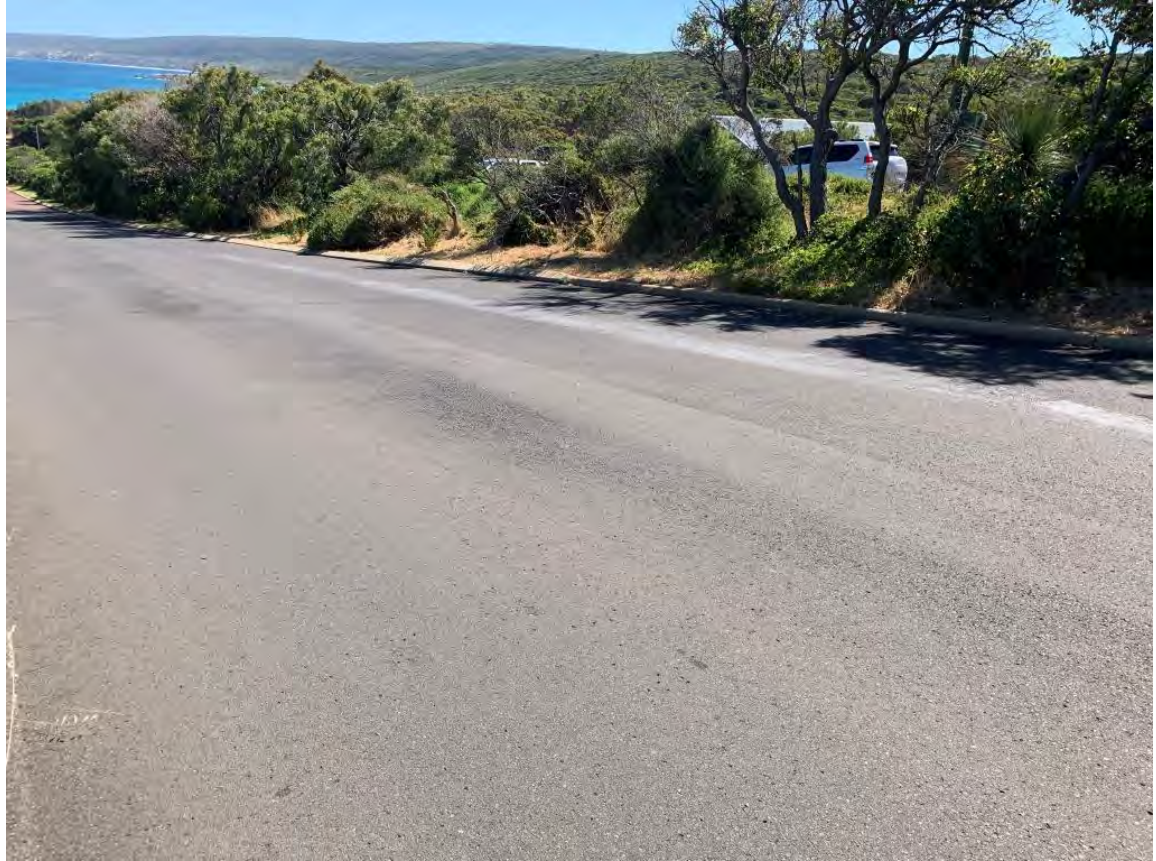
<p>Ravelling on the inner wheel path of the northbound lane</p>

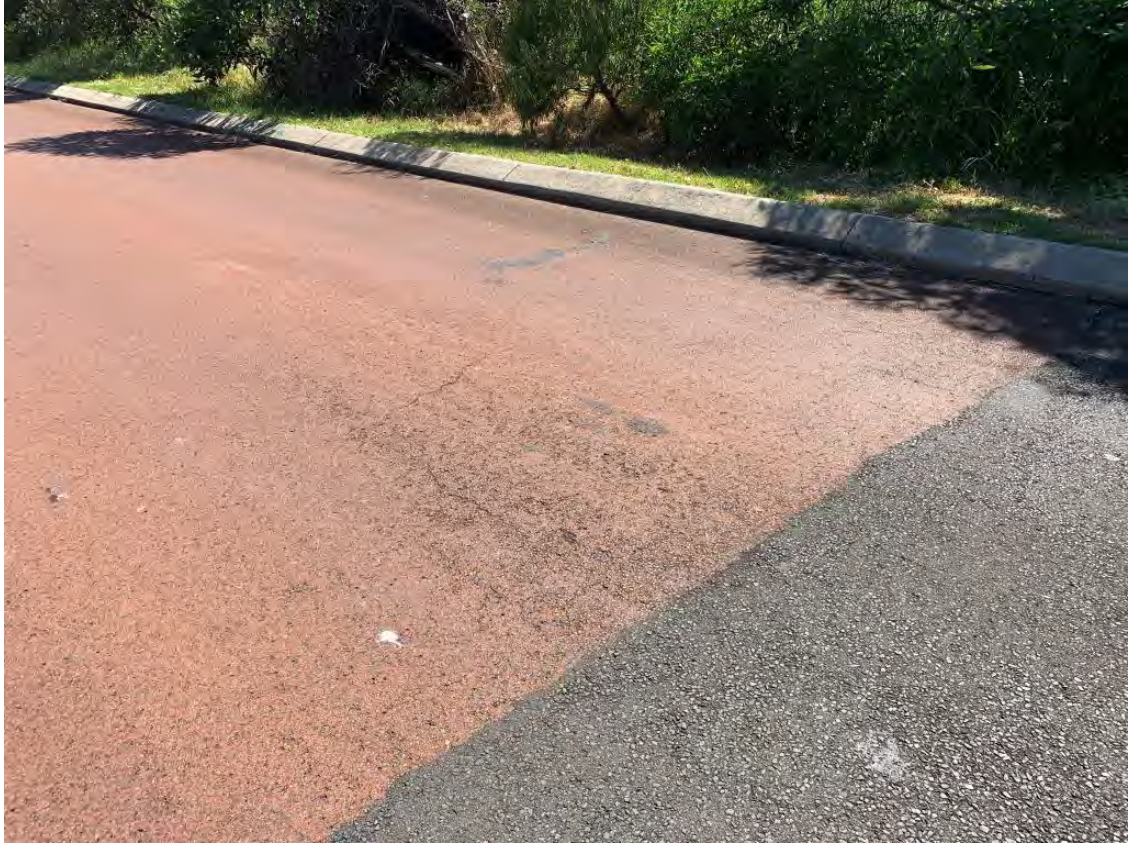
Transverse and longitudinal cracking between the lanes. Minor ravelling observed.

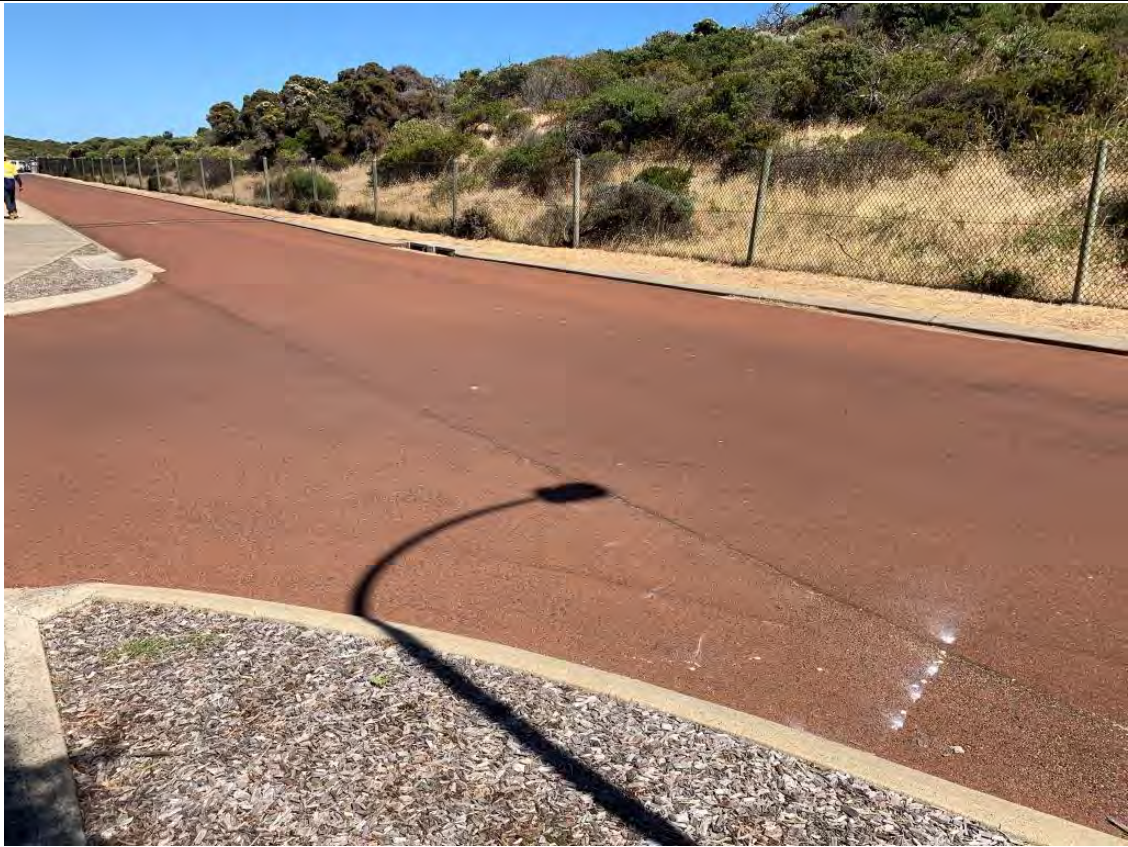
<p>Some minor cracking along the joints and pumping of fines. Minor ravelling within the turning pocket.</p>

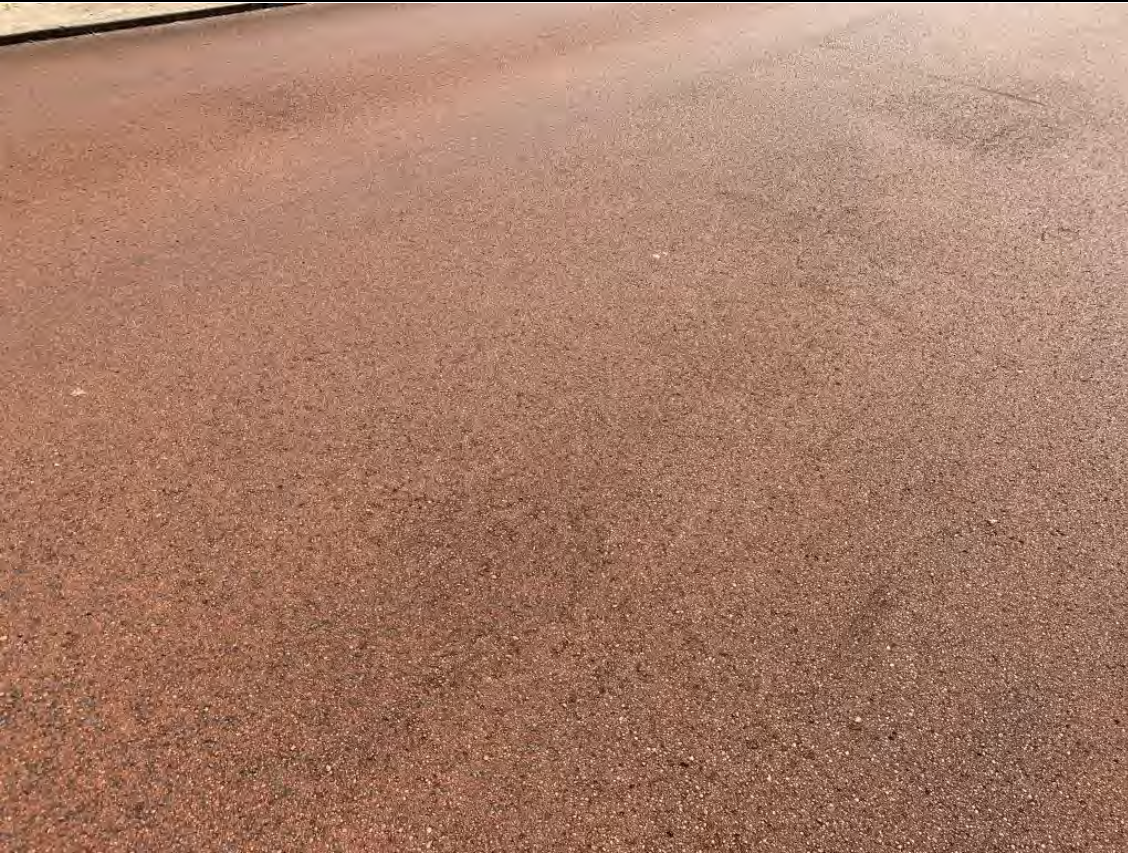
<p>Close up of pavement – small pin holes were generally observed on the pavement surface, as well as minor ravelling at localised spots, between wheel paths. Pavement may have been constructed during wet or cold weather.</p>

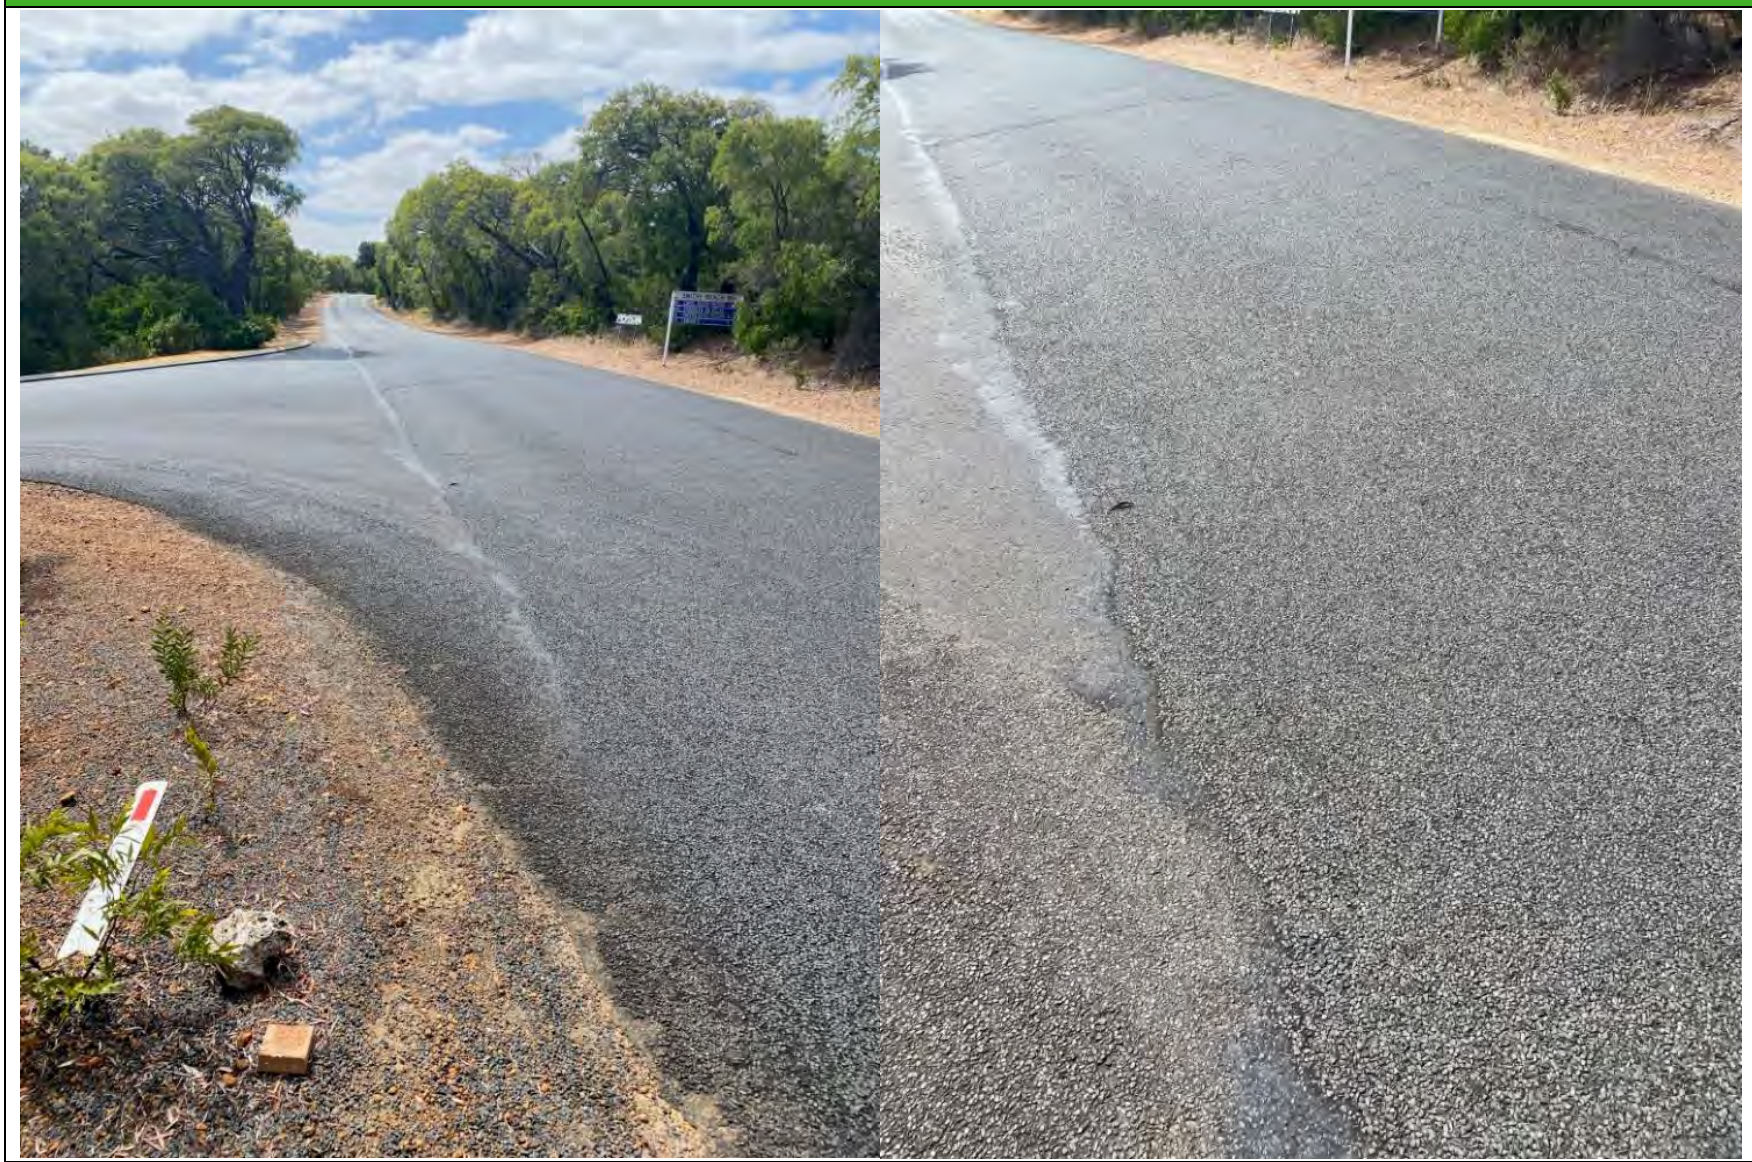
<p>Intersection stub of Canal Rocks Road and Smiths Beach Road – the asphalt surfacing joins to a spray sealed through lane and the joint sealing is relatively poor. Spray sealed shoulder on the left turn heading north widens the intersection stub, some minor stripping observed on the sealed surface.</p>

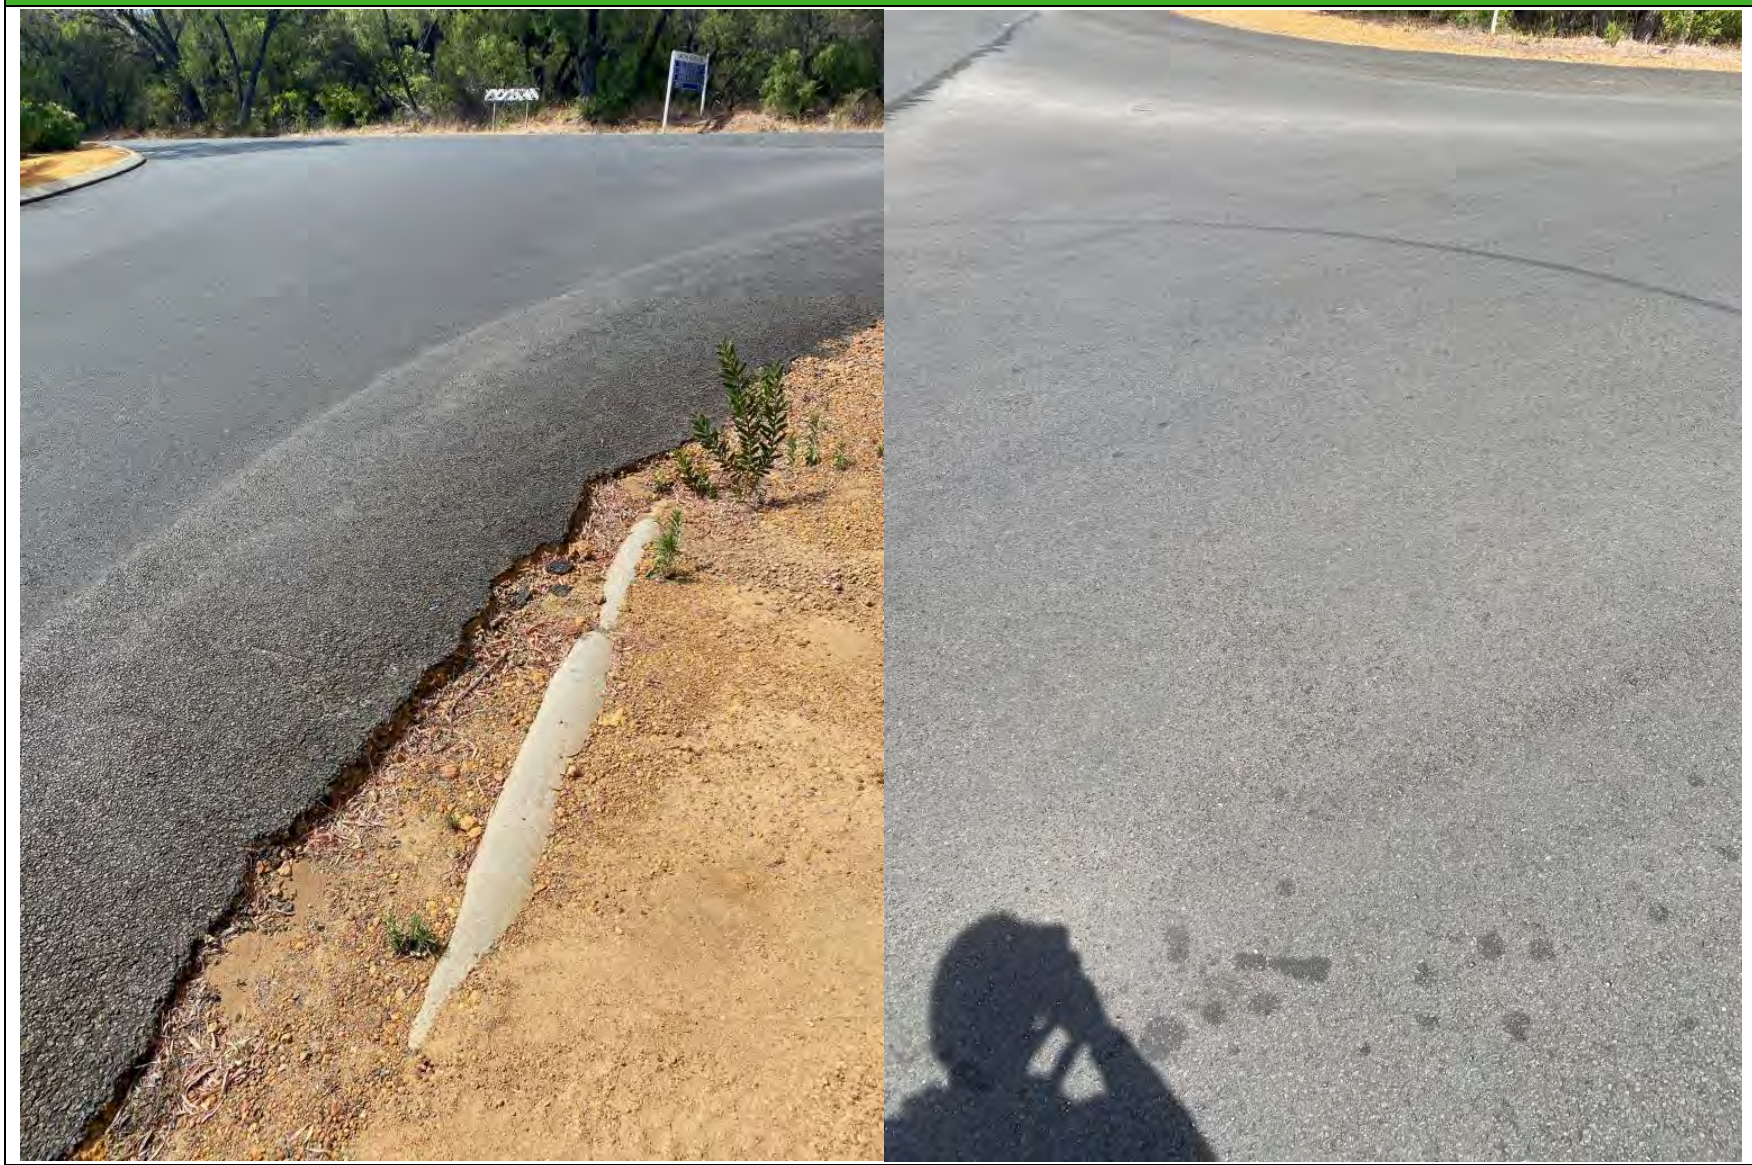
<p>Edge break and drop off along the edge of the northbound lane (spray seal) and pumping of fines along the joint. Some ravelling was also observed on the wheel path of the turning lane (asphalt surfacing).</p>

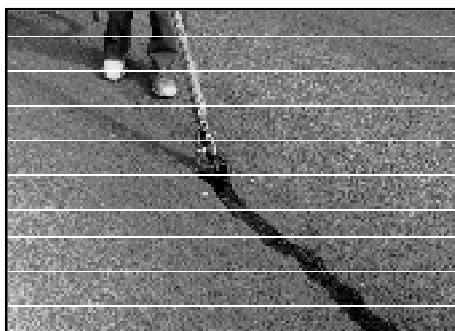
Crack filling with insulated hand lance

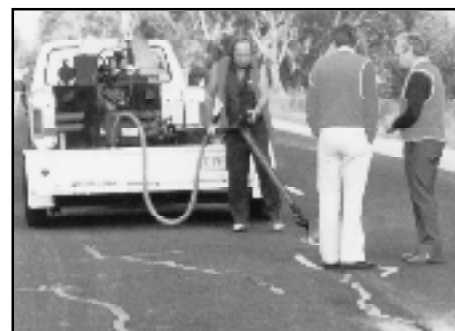
Filling and sanding cracks after routing
