91 CANNING HIGHWAY, EAST FREMANTLE

Heritage Assessment

June 2011

HHS Job No. 2011-22

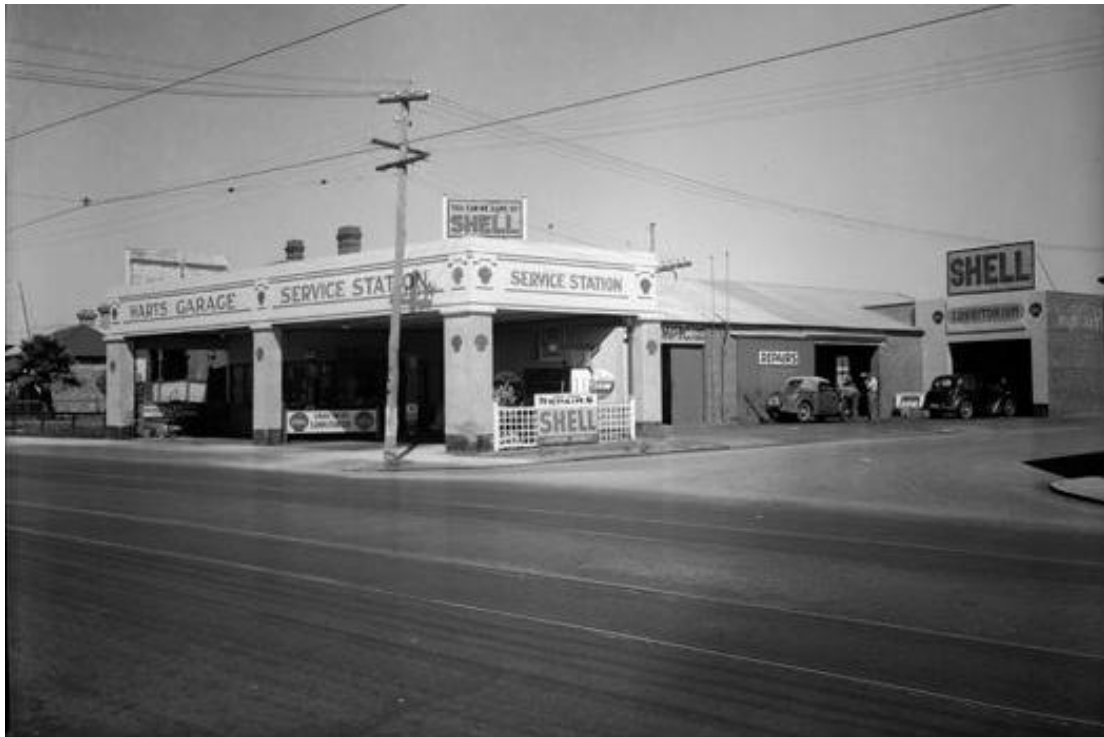
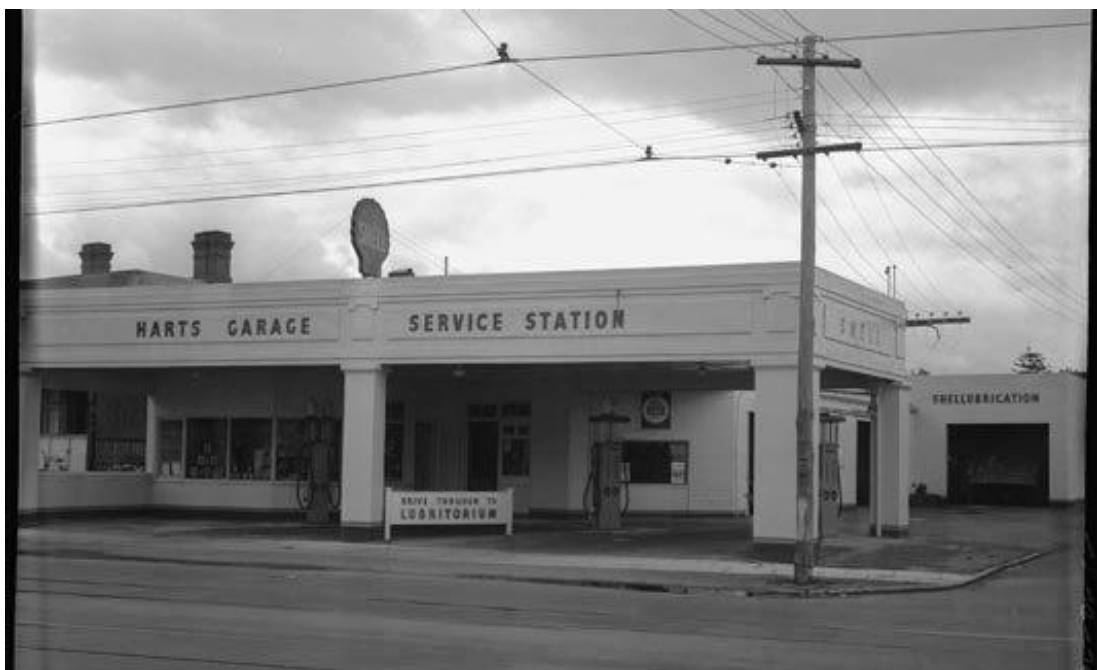
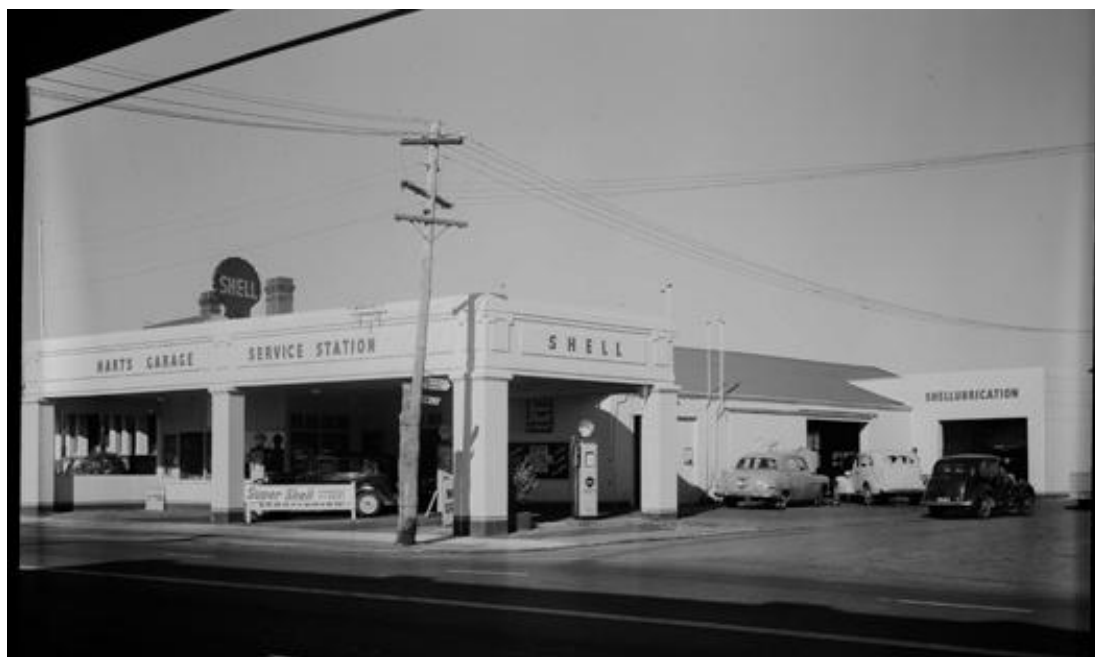
Figure 8 Photograph of Harts Garage, 1951. Courtesy State Library, image 234866PD.

Figure 9 Photograph of Harts Garage, 1952. Courtesy State Library, image 8292B-27167-1.

Figure 10 Photograph of Harts Garage, 1955. Courtesy State Library, image 8292B-27167-1.

The place, as seen in figures 7-10 above, had a prominent rendered brick canopy with deep moulded fascia incorporating the name of the garage. The forecourt was open to both Canning Highway and Sewell Road with the canopy being a regular rectangular shape. The shop front was 'L' shaped with an angled shop window and a chamfered edge to the north-west corner.

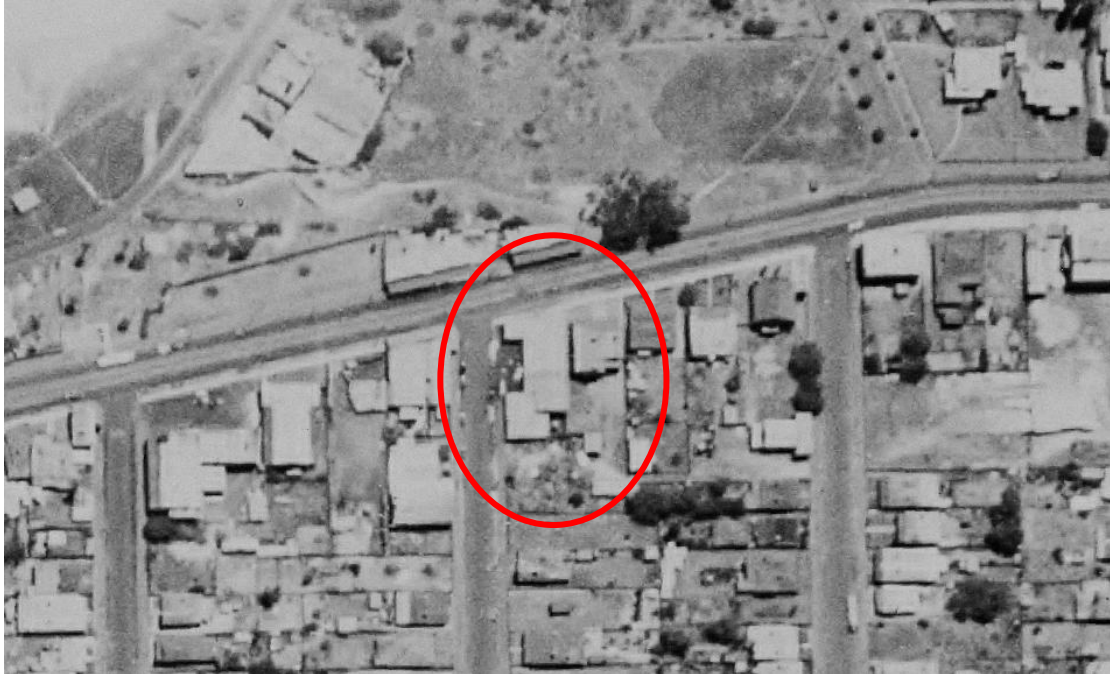
Figure 11 Aerial photograph 1953. Courtesy Landgate.

In 1953, it can be seen that the properties conformed in layout to the 1950 sewerage plan. The two buildings are separated and it appears that the verandah is still present on the west side of the residence.

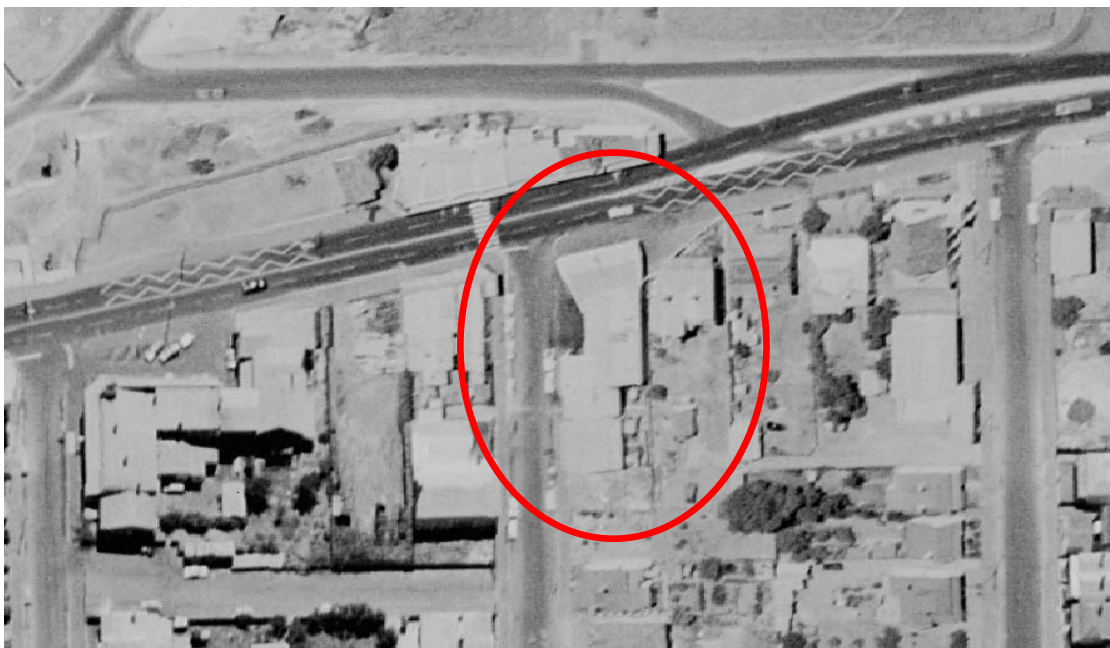
Figure 12 Aerial photograph 1965. Courtesy Landgate.

By 1965 the awning over the apron of the service station has been altered and the entry to the station encroaches on the front yard of the residence.

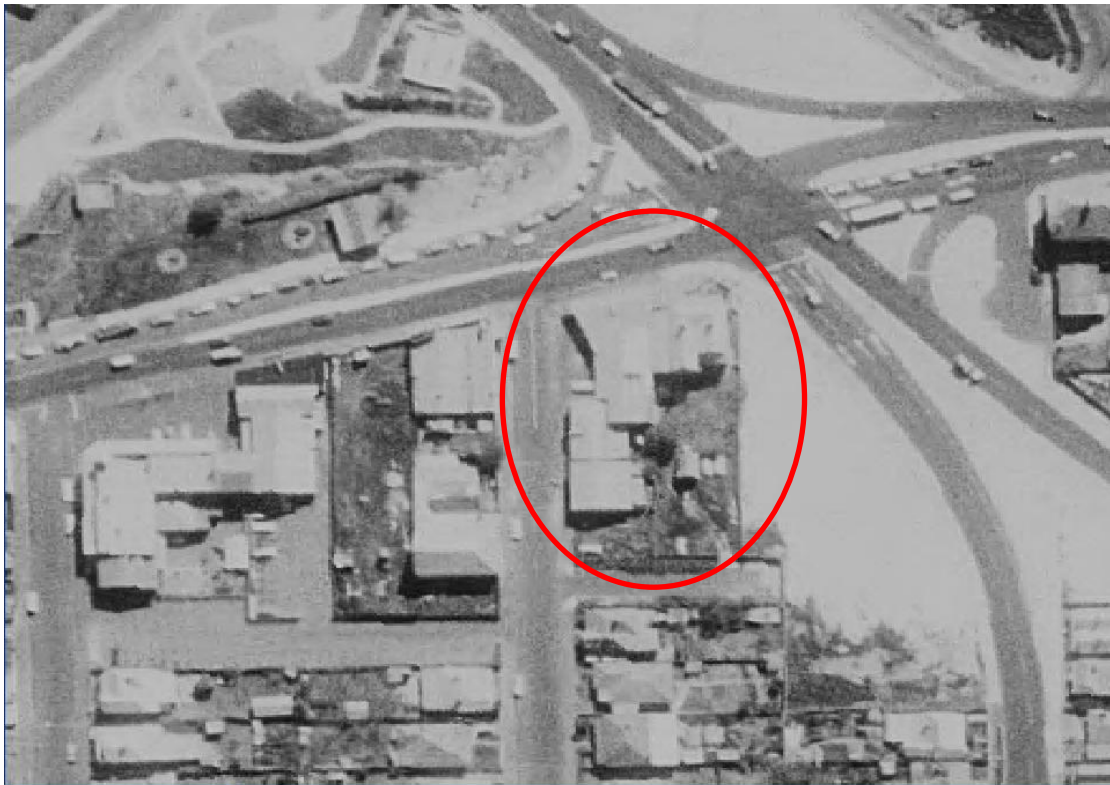
Figure 13 Aerial photograph 1974. Courtesy Landgate.

With the construction of the Stirling Bridge and the associated on ramps the three buildings to the east of the subject site were demolished. The space between the two buildings on the site has been enclosed probably removing the original verandah.

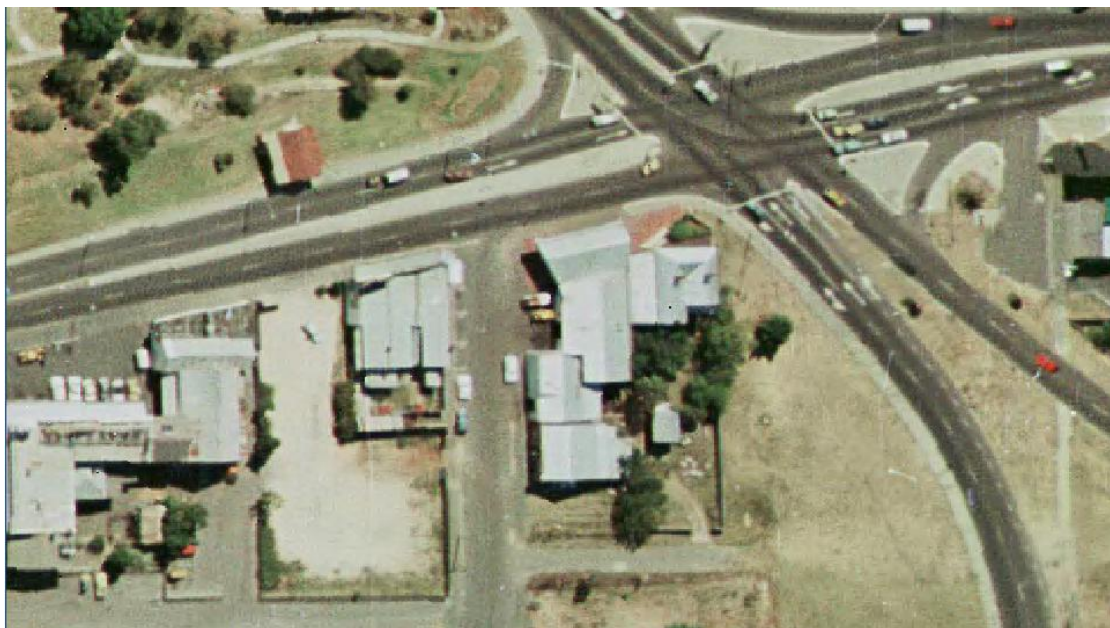
Figure 14 Aerial photograph 1985. Courtesy Landgate.

The buildings have not changed considerably since the 1970s apart from the rear of the residence which has now been paved.

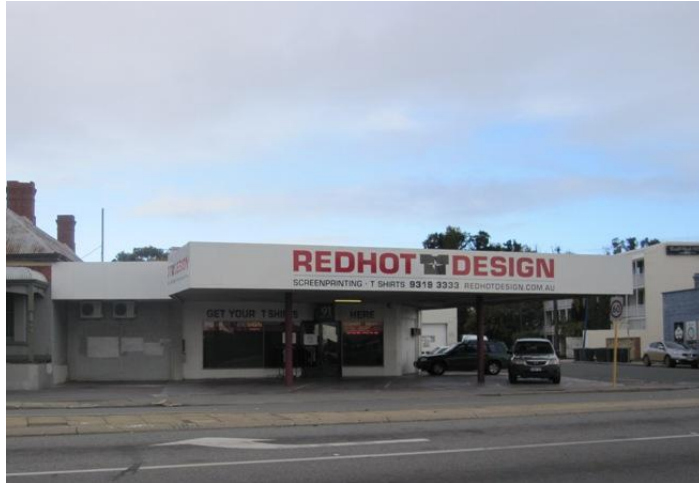
The *Garage (fmr)*, 91 Canning Highway as it presents to Canning Highway is a much altered structure from its original construction.

Figure 15 Garage (fmr), 91 Canning Highway

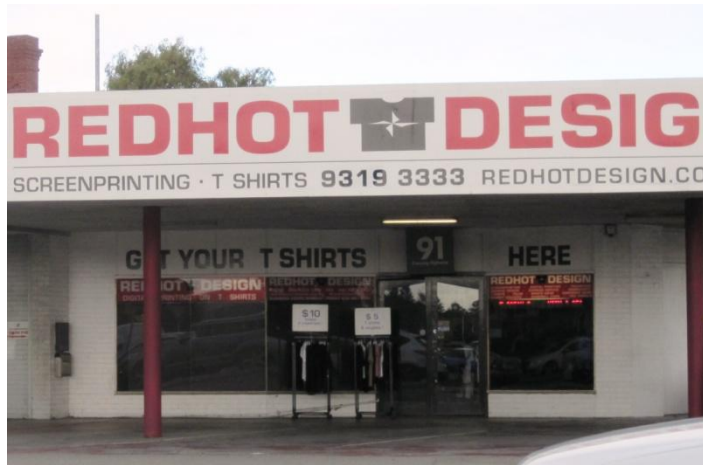
The front elevation of the garage and the canopy/forecourt area underwent works of alteration in the 1960s which saw a remodelling of both elements into the current form. The rendered brick canopy was removed and a new canopy constructed which was larger and wider, with an angled edge to the western side. The distinctive 'L' shaped shop front was reshaped to create a flatter elevation. The window dimensions were enlarged and the entrance door moved. Additional doors were inserted into the chamfered north-west corner. The petrol pumps have subsequently been removed to create an open parking area and has been resurfaced with pre-cast concrete pavers. Much of the original fabric and architectural detailing which gave the garage its distinctive aesthetic qualities has been lost.

Figure 16 Shop front of former garage, 91 Canning Highway

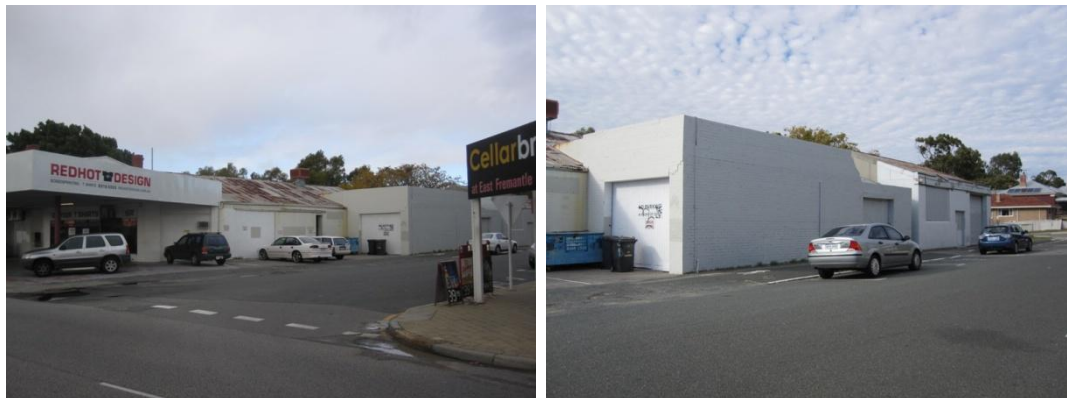
The west elevation is of brick construction. The wall contains remnants of a sculptured parapet wall with a low pitched roof behind. The rear section was originally a separate shop, the window and door openings still punctuate the elevation but the window has been covered with Kliplok cladding with a metal door and a metal roller shutter to the south.

Figure 17 West elevations, 91 Canning Highway

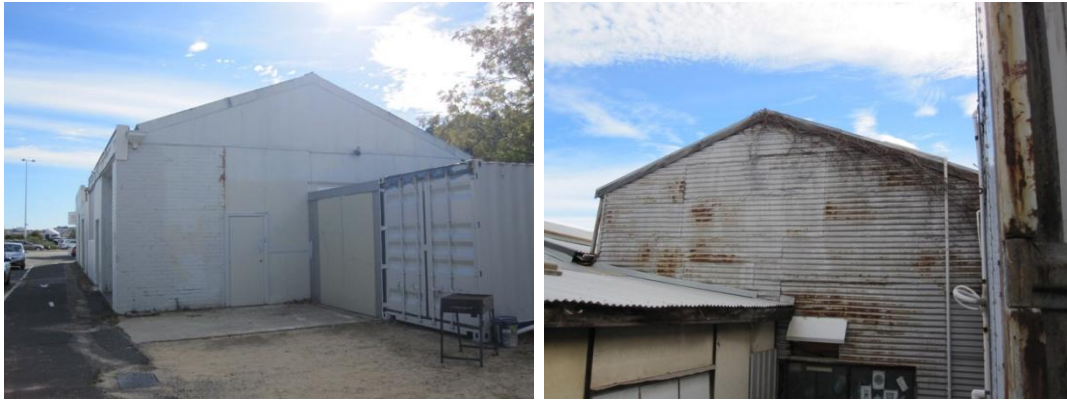
The south elevation is predominantly of brick construction together with fibro panel cladding and two storage containers have been placed at the rear of the main accommodation.

Figure 18 South elevations, 91 Canning Highway

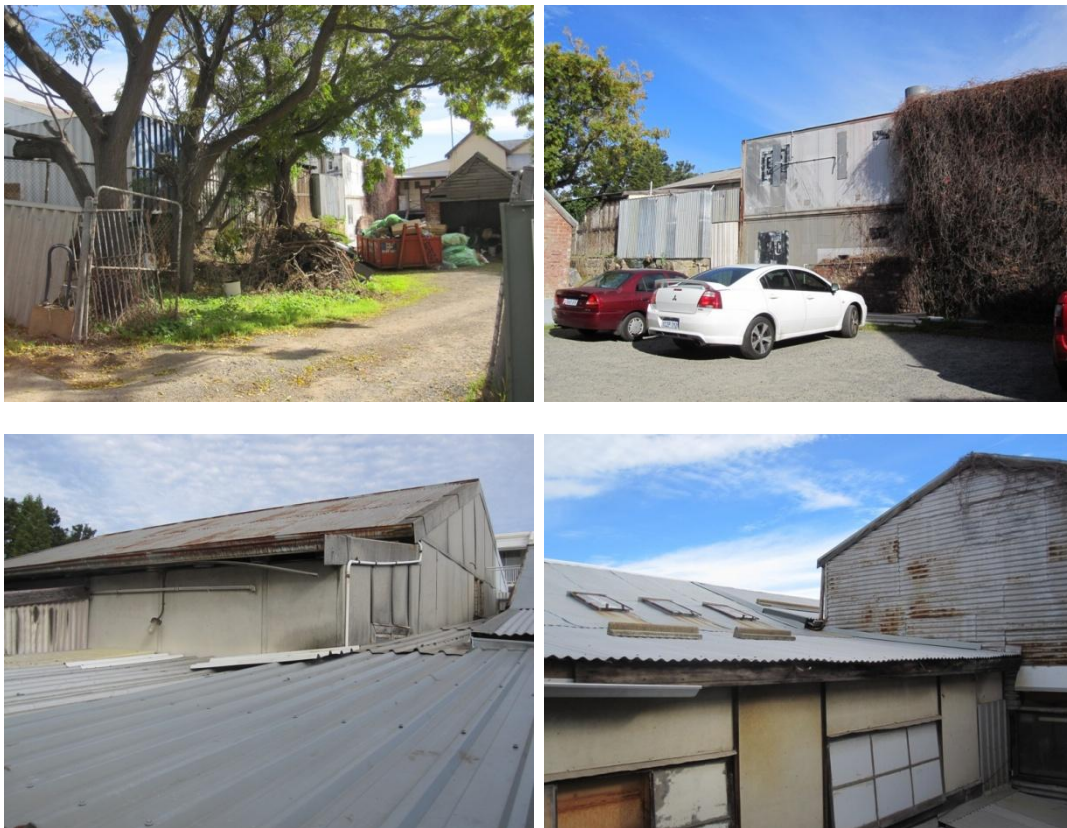
The east elevation clearly demonstrates the accretions that have been added in an ad hoc manner over the years and do not contribute any aesthetic value to the building. Whilst the building form presents as a series of lean-to type additions, the elevations consist of a patchwork of materials, layered over each other and taking no account of the original materials or construction methods. The site slopes away from the front of the building and at this juncture the change in levels is clearly illustrated with a timber staircase leading down to a sunken yard which is full of plant and machinery. The ground level of the building is marked by the row of red bricks on top of the limestone plinth.

Figure 19 The various forms of the east elevation, 91 Canning Highway

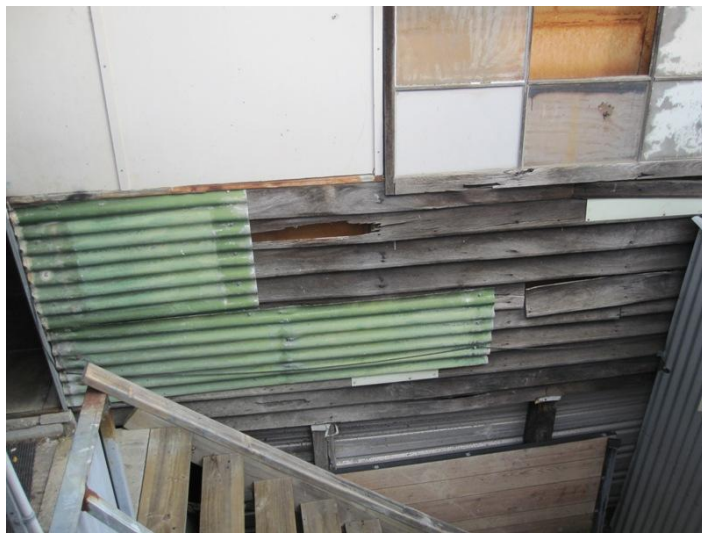
The condition of the building is poor to fair. Much of the brickwork is painted so the condition of the bricks could not be ascertained but there are numerous cracks along the joints and a number of the bricks appear to be pushing forward which could create an unstable wall. The roof of the front section of the former garage and the canopy could not be inspected due to lack of accessibility but all other visible roof surfaces are showing signs of rust and decay. The CGI panels to the elevations are rusting and beginning to come loose. The fibro cladding additions are also showing signs of age and deterioration. The lean-to additions along the eastern side of the building demonstrate low basic construction methods and daylight is visible through many of the joints. The patchwork method of repairs overlaying different materials on top of original materials does not treat the cause of any issue, rather is just a superficial remedy which can potentially exacerbate problems.

Figure 20 Patched repairs on east elevation, 91 Canning Highway

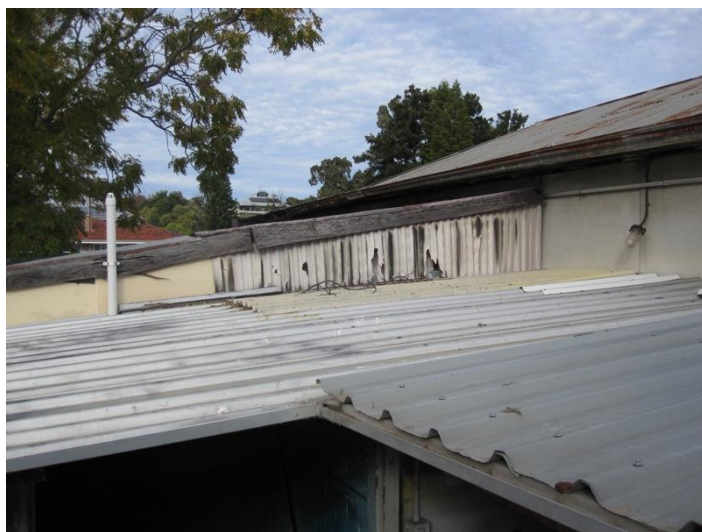
Figure 21 Poor condition of materials, 91 Canning Highway

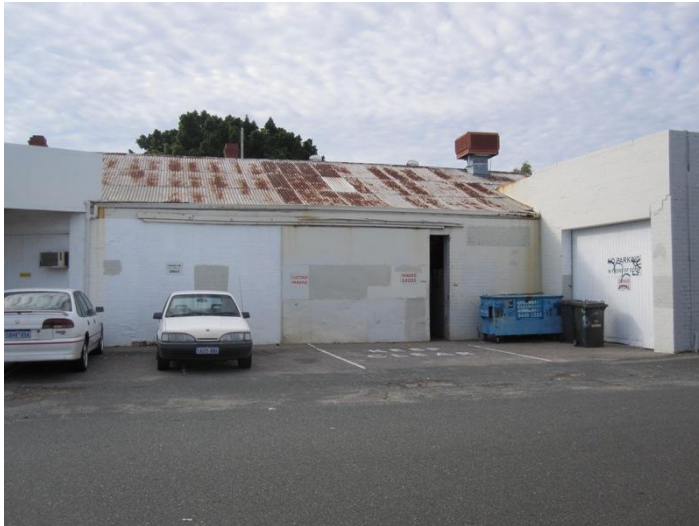
Figure 22 Rusted roofs and patched elevations and doors, 91 Canning Highway

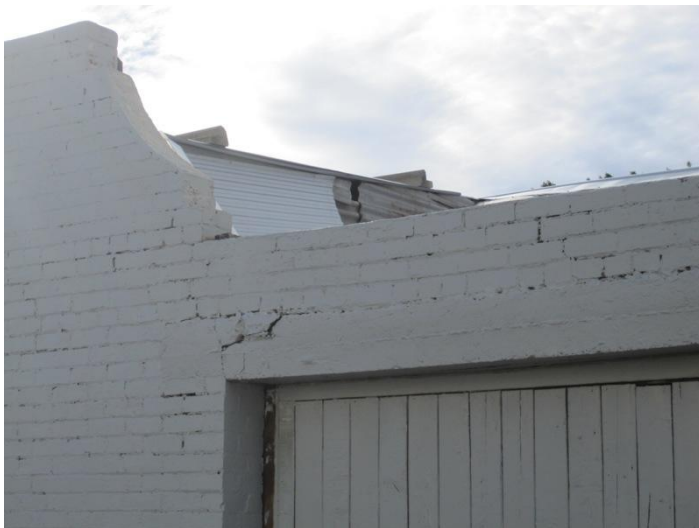
Figure 23 Failing brickwork and patched roofs, 91 Canning Highway

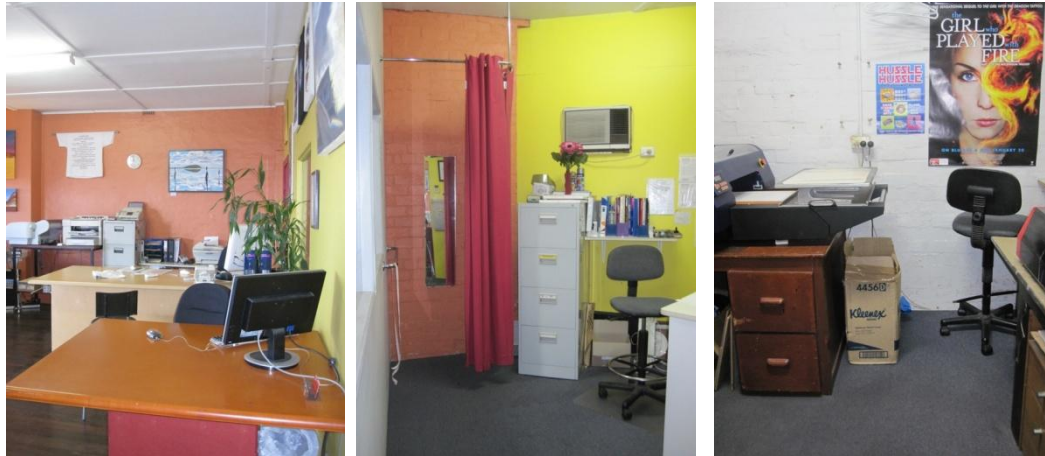
To the front of the space is the main showroom and two small partitioned offices. The offices have panelled ceilings with fluorescent strip lights. The two smaller spaces have carpeted concrete floors whilst the main showroom/front office has timber flooring.

Figure 24 Office space, 91 Canning Highway

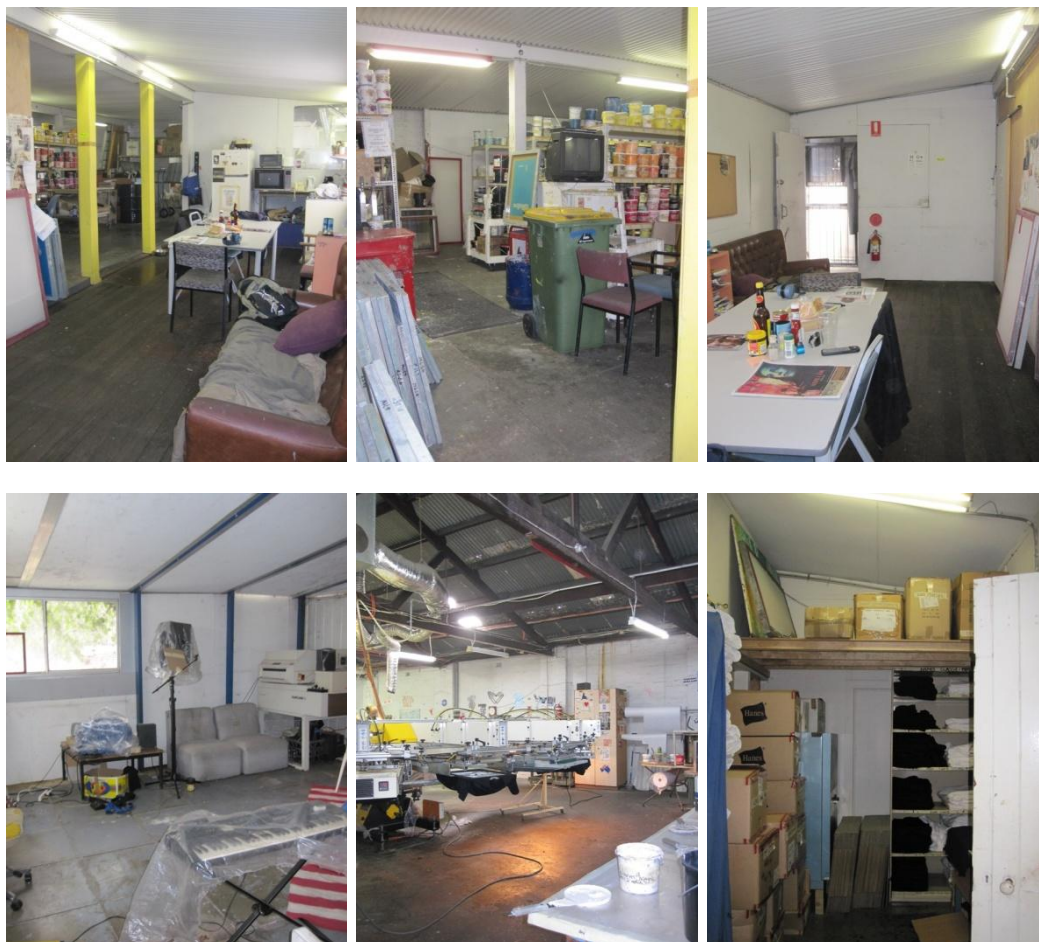
To the main spaces, the walls are unlined brick or fibro panel walls and floors are either concrete or timber. The main production space which forms part of the original garage is open to the roof. The trusses are supported on brick pilasters with fluorescent lights suspended from the beams. The corrugated iron roof sheets are rusted to the underside especially around the roof battens. Skylights allow a small amount of natural light to come

through the roof space. Extraction tubes are strung all through the roof trusses and attached to flues in the roof.

Figure 25 Warehouse and amenity space, 91 Canning Highway

The condition of the internal spaces is poor to fair.
