93 CANNING HIGHWAY,

EAST FREMANTLE

Heritage Assessment

June 2011

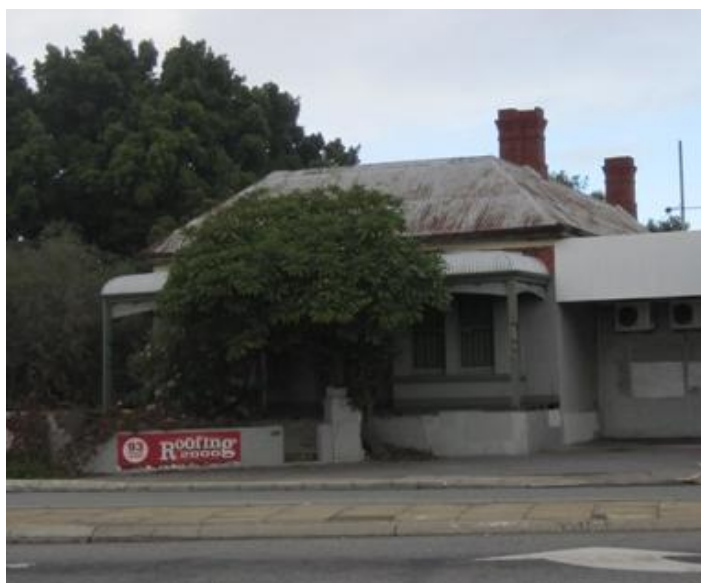
Figure 16 **93 Canning Highway**

The front elevation presents as a typical dwelling from this era and is characteristic of the small cottages seen in and around Fremantle. The house is of brick construction, painted grey to the front elevation and cream painted brick to the east and south elevations. The east and south elevations illustrate the change in land level towards the rear of the house where the brick section of the dwelling sits on top of a limestone footing. The roof is corrugated galvanised iron, hipped to the front and twin gables to the rear. There are two red brick chimneys on the western side of the roof but the chimneys on the eastern section have been removed.

The front verandah is raised approximately 800mm above ground, accessed by 5 steps. A rendered and painted limestone retaining wall supports the decking around the edge and is presumed that timber stumps will support the main body of the decking. The verandah is open with no form of balustrade. The earliest photograph that was found of the building dates from 1951 (Figure 9) and shows a timber balustrade to the front verandah and a lattice infill to the side section. The bullnose canopy is supported on turned timber columns with a timber bressumer extending between the columns. The original canopy was a flat bullnose canopy, the original position of which can still be seen on the face of the building.

The present canopy is a low pitched hipped bullnose canopy. The timber columns appear to be the originals and together with the timber decking remain the only original fabric.

A centrally placed timber panelled door with side lights is flanked by twin bay windows, both of which still contain the original double hung timber framed sashes. Each window within the bay is separated by painted brick piers with a contrasting painted sill.

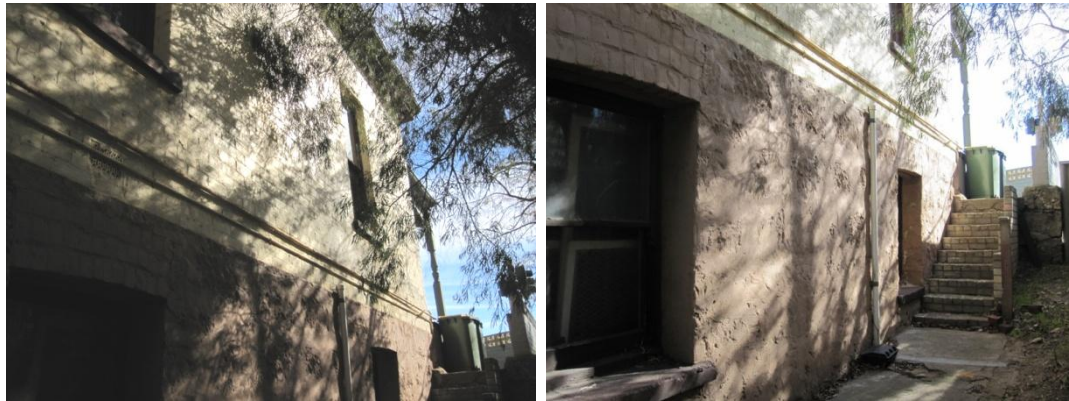
Figure 17 East elevation, 93 Canning Highway

The east elevation is predominantly a blank elevation with timber framed sash windows in the Victorian style of 1-over-1 panes to the main dwelling with additional windows of the same style to the basement accommodation. The basement windows have a triple row of header bricks as a window arch. A timber staircase leads up to the rear verandah.

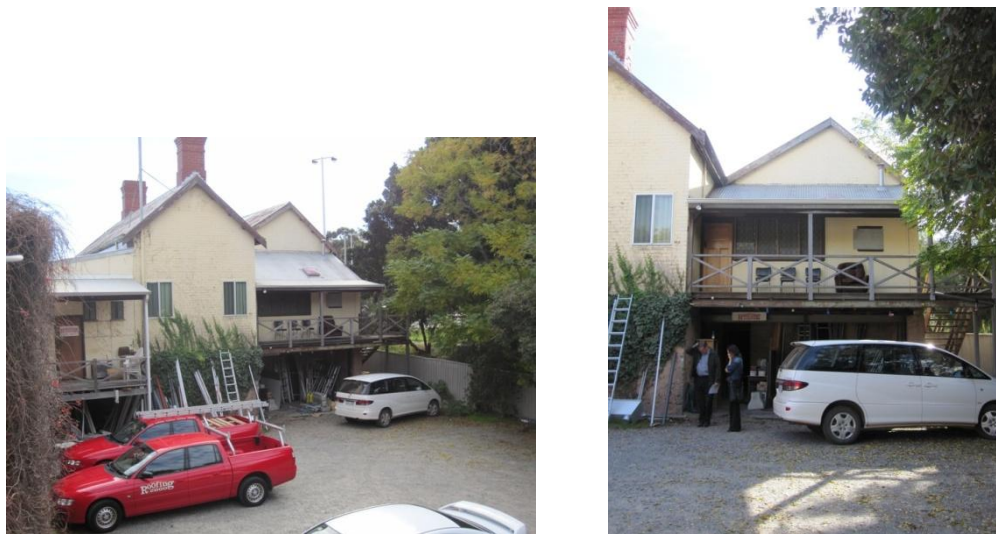
Figure 18 South elevations, 93 Canning Highway

The rear elevation, although altered, still presents as originally constructed. The rear of the house consists of two gabled wings, the west wing projecting forward and a verandah extending across the east wing. Part of the verandah has been enclosed with fibro cladding but the verandah itself is the original. The windows in the west section have been replaced with metal framed openings.

The rear elevation presents as a two storey structure although it is a single storey dwelling with basement. The verandah projects over the entrance into the basement which is via a single door leading into the main basement area with a secondary door into the space under the west wing.

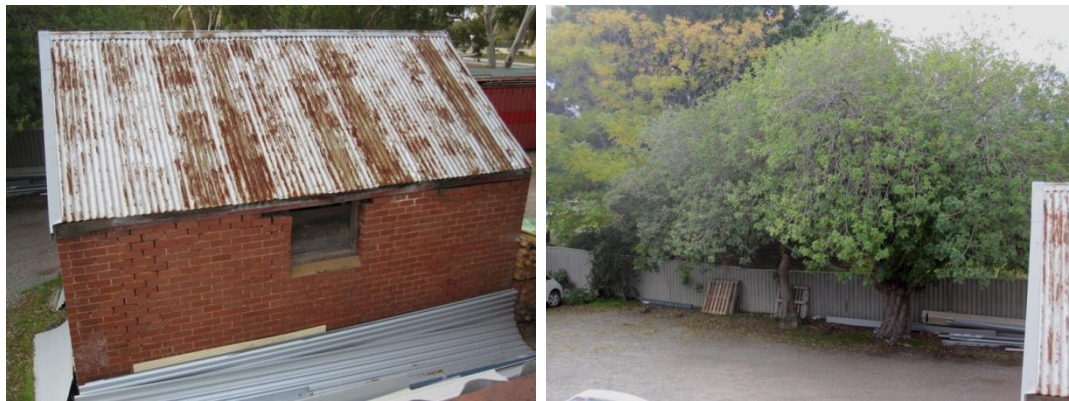
Figure 19 Out house and parking area, 93 Canning Highway

The area to the rear of the property is rough gravel and used for parking. A small red brick and tin outhouse is within the yard.

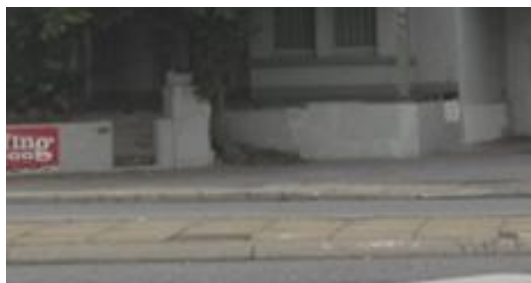
Overall the dwelling appears to be in a fair condition. The steps and retaining wall to the front verandah are showing signs of failure with the render falling off the wall and the steps cracking. The roof is rusted. Mortar is missing from the chimneys and the bricks on the south chimney appear to be loose. The eaves to the front of the building are showing signs of rotting underneath the gutters. There is evidence of repair to the apex of the west gable. All the timber is in need of repainting.

Figure 20 Poor condition of retaining wall and steps, 93 Canning Highway

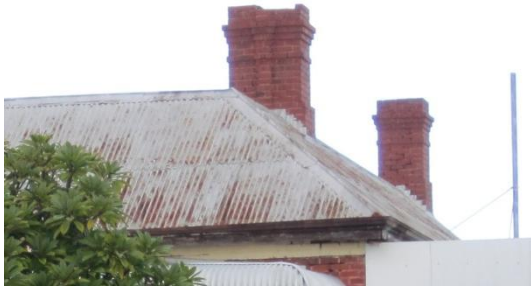
Figure 21 Rotting eaves and poor brickwork to chimney, 93 Canning Highway

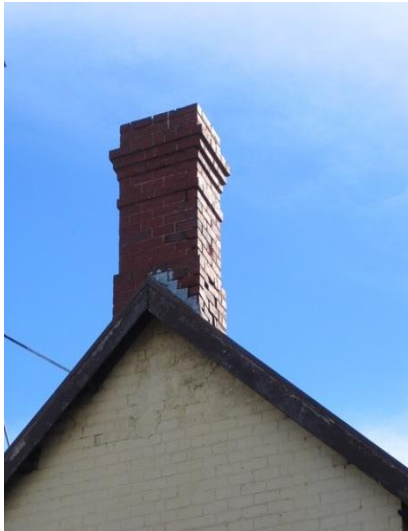
Figure 22 Poor brickwork and mortar, 93 Canning Highway

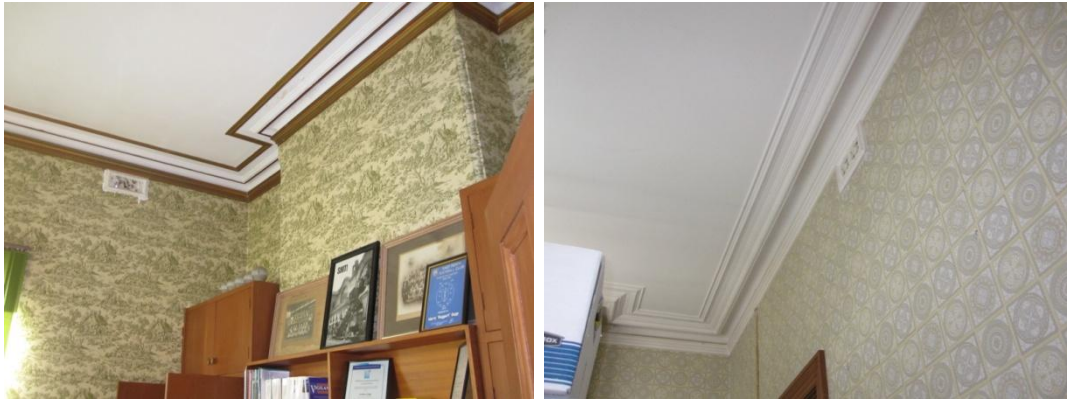
Figure 23 Cornice and air vents, 93 Canning Highway

The front door leads into a long passageway running through the entire building with rooms off to both sides. The passageway has high ceilings with the original decorative roses. The walls are lathe and plaster. An archway with decorative nibs is positioned halfway down the corridor with the architectural treatment being more decorative towards the front of the house and less ornate towards the rear section which is reflective of the more public use of the rooms to the front of the house.

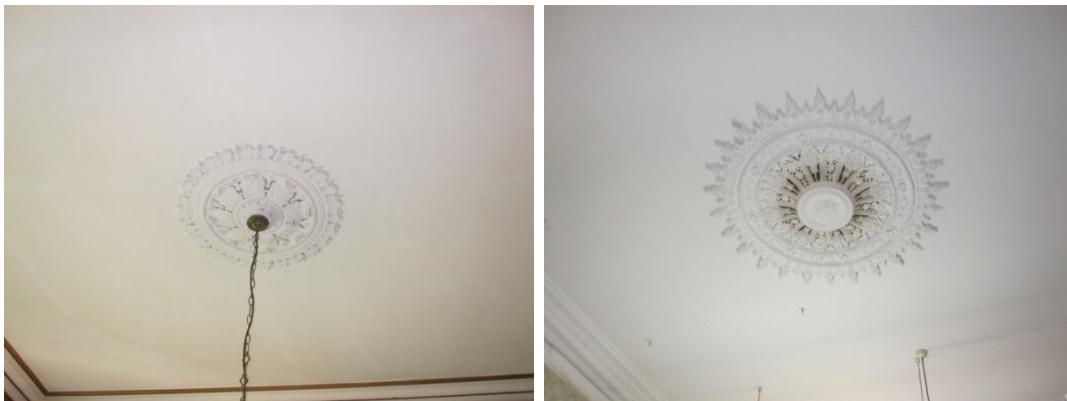
Figure 24 Ceiling roses, 93 Canning Highway

There are six rooms off the corridor, three to each side with the four main rooms all of similar decorative order. The four rooms, now utilised as offices, all have fire places and projecting chimneys, decorative cornice, high level decorative air vents, ceiling roses and deep moulded skirtings. The floors are jarrah boards.

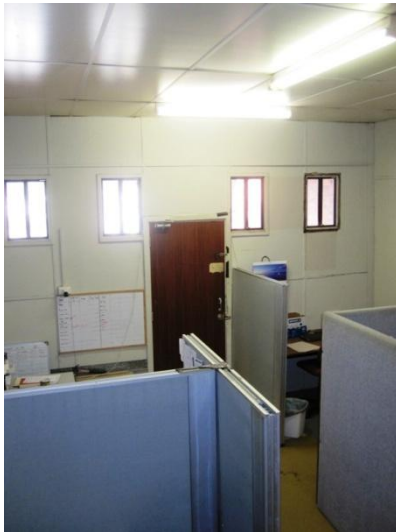
Figure 26 Additional accommodation, 93 Canning Highway

The addition is accessed from the central office down a flight of stairs into an open plan office space. A row of four small windows is situated in the west wall together with a flush panel timber door. The west wall is fibro panel with the west and north wall being plastered and painted brick work. The ceiling is acoustic tile with fluorescent strip lighting.

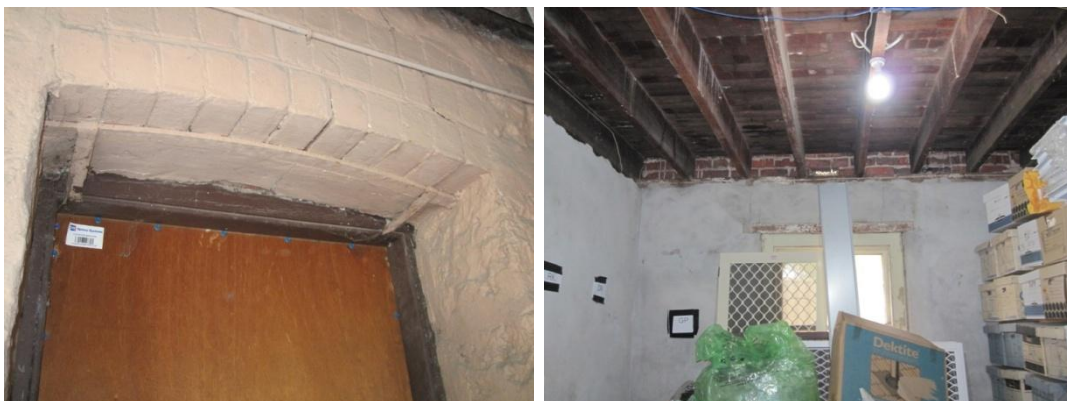
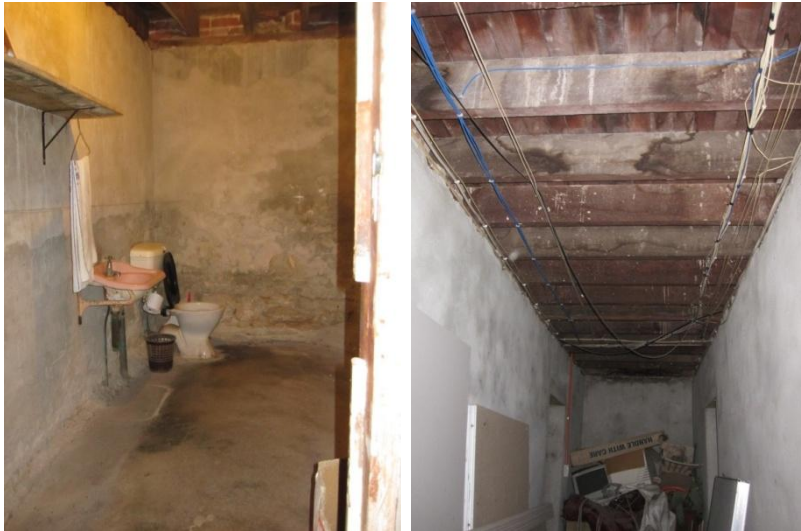
Figure 27 Basement accommodation, 93 Canning Highway

The basement comprises a series of rooms, two of which have windows along the east wall but most lack natural lighting. The walls and floors have been tanked with concrete whilst the ceiling is formed by the underside of the floor to the dwelling above. Plumbing and electricity have been installed within the space.

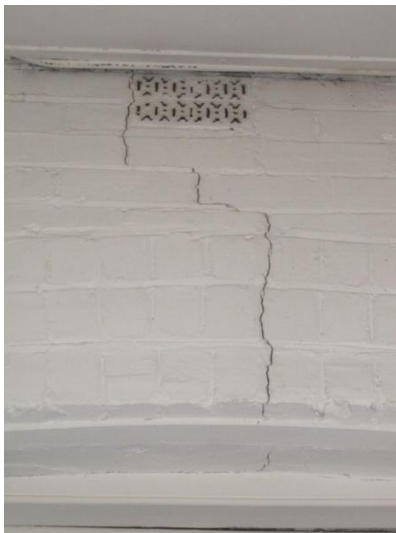
The interior of the dwelling is showing signs of damp, especially to the ceiling in the hall way where the ceiling is in a bad condition near the arch. There are a number of cracks throughout the building which require attention. The kitchen and bathroom services are functional but basic.

Figure 28 Crack above door to verandah, 93 Canning Highway
