3 February 2021
Job Number: 21117
Our Reference: 01L

LIMESTONE WALLS, LOT 12 (HN 65) SOUTH TERRACE, FREMANTLE-HERITAGE ASSESSMENT

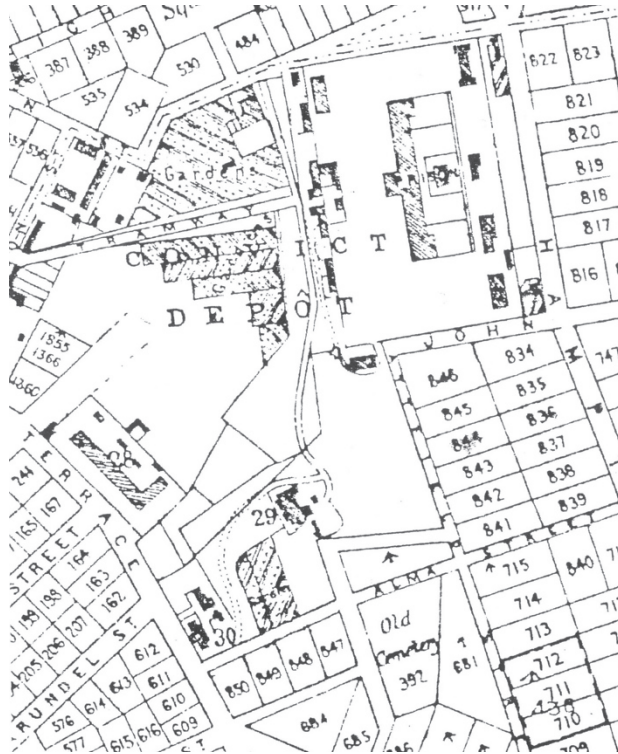
Plan of the Town of Fremantle, 18/12/1892. This indicates that Lots 162-164 fronted South Terrace. There are currently houses to the west on Lot 199 Sussex Street and Lot 207 Arundel Street.

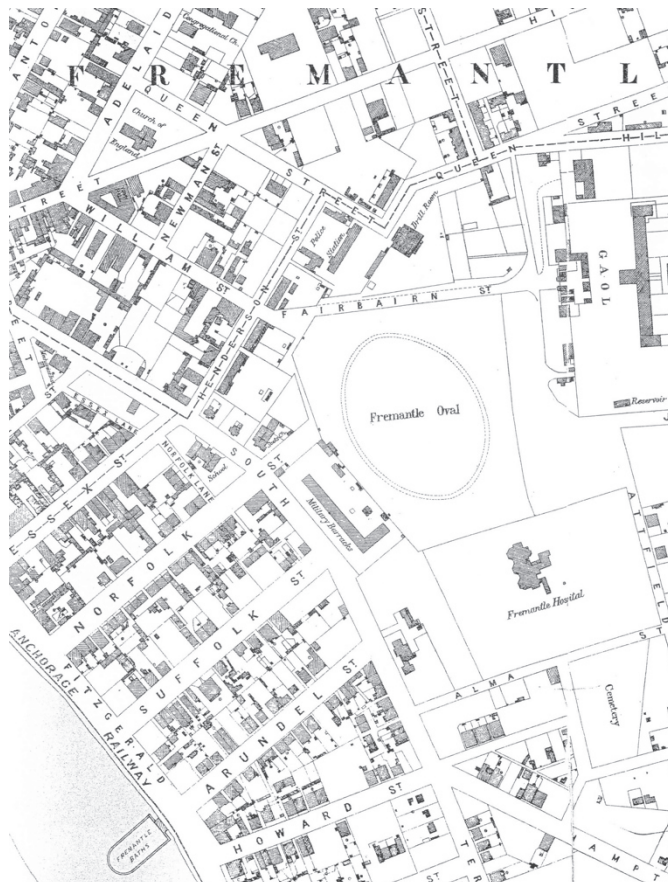
Part plan, WA Harbour Works Plan, showing extent of works constructed and provided for 31 July 1898, PWD 6409. See the small amount of development indicated on the current Lot 12

By 1898, the plans indicate a number of shed structures to the south the current Lot 12.

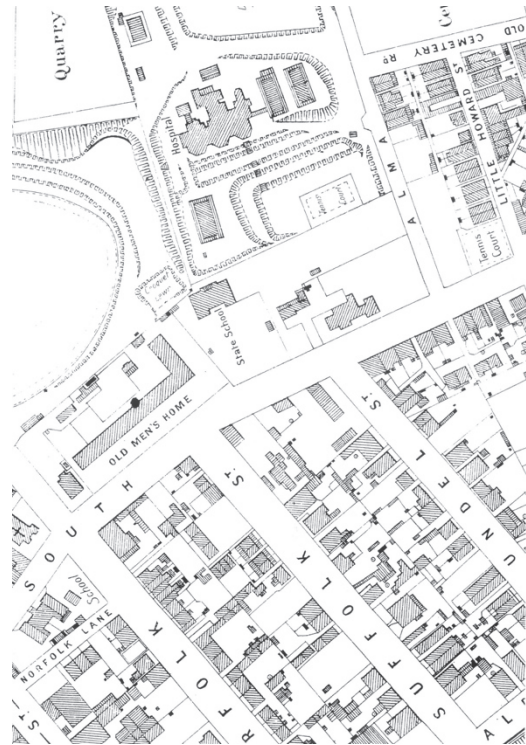
Plan of Fremantle 22 February 1913, PWD13017 indicating a scattering of buildings across the three lots.
