## Stage 1: - Preliminary Tree Survey Report 91-95 Canning Highway, East Fremantle, Western Australia November 2021

Reference Number: Q004170

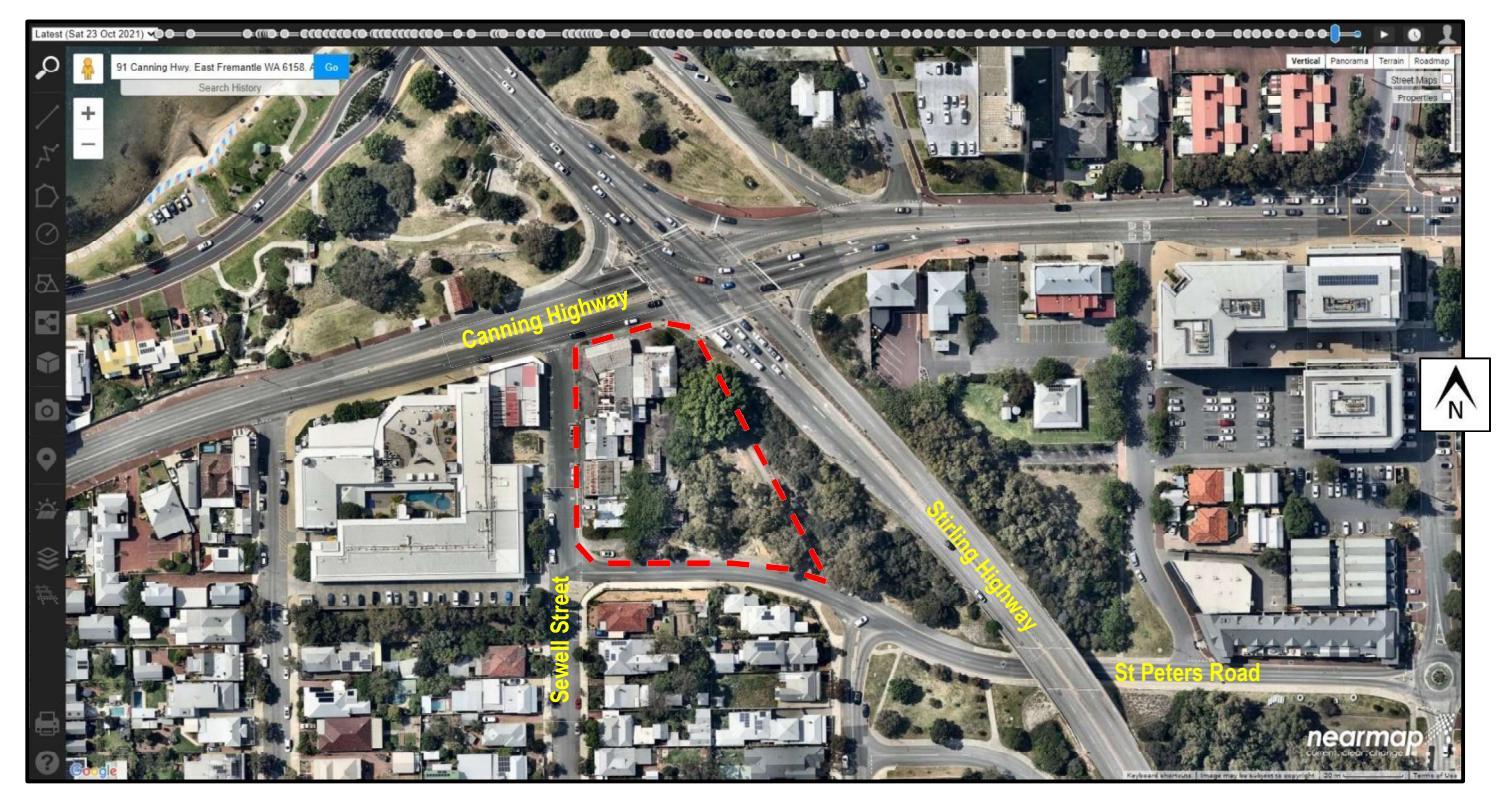
Figure 1. Satellite image showing approximate area assessed within The Proposed Development, located at 91-95 Canning Highway, East Fremantle, Western Australia. Image Source – www.NearMap.com , Image date 23rd October 2021

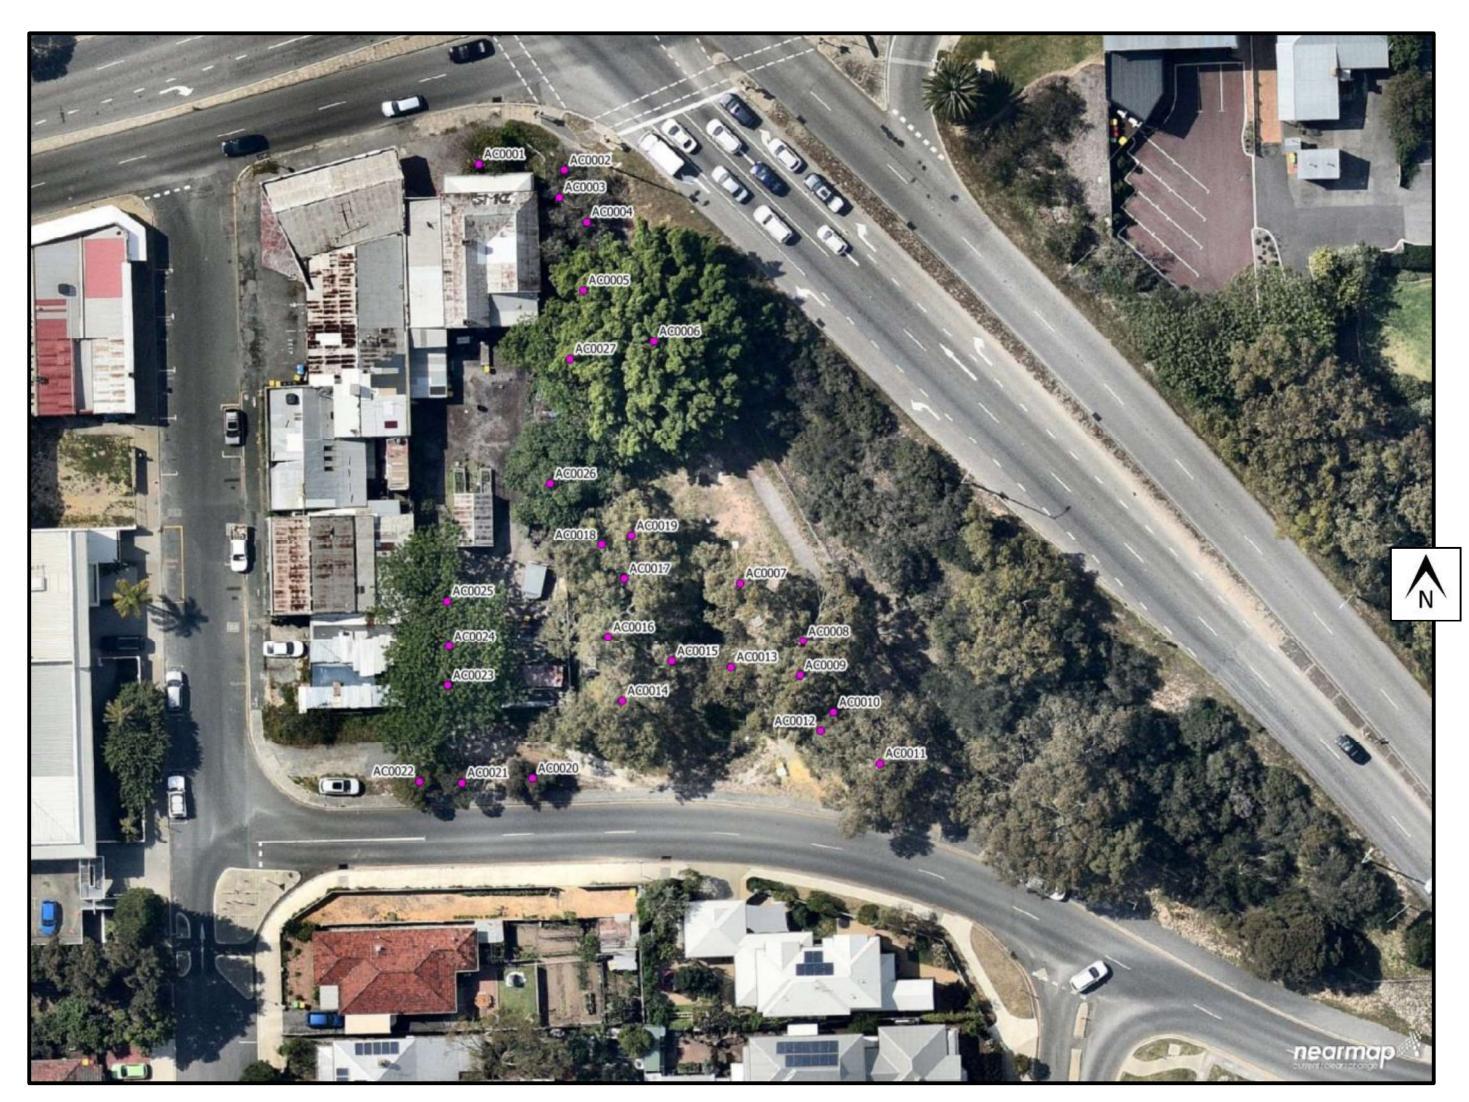
Figure 2: Tree location Image. Image Source – www.nearmaps.com , Image date 23rd October 2021

Note: Tree locations are an approximate and for reference purposes only (the GIS coordinates are to be used as a <u>quide only</u> to verifying location and tree specific information). The GIS Data is deemed reliable but provided "as is" without warranty of any representation of accuracy, timeliness, reliability or completeness. The map documents do not represent a legal survey of the land and are for graphical purposes only. Use of the Data for any purpose should be with acknowledgment of the limitations of the Data, including the fact that the Data is dynamic and is in a constant state of maintenance, correction, and update.
