TARGETED SOIL INVESTIGATION

FORMER SHELL EAST FREMANTLE SERVICE STATION 91 CANNING HIGHWAY, EAST FREMANTLE, WESTERN AUSTRALIA 6158

GEMEC Pty Ltd (ABN 13 094 203 639)

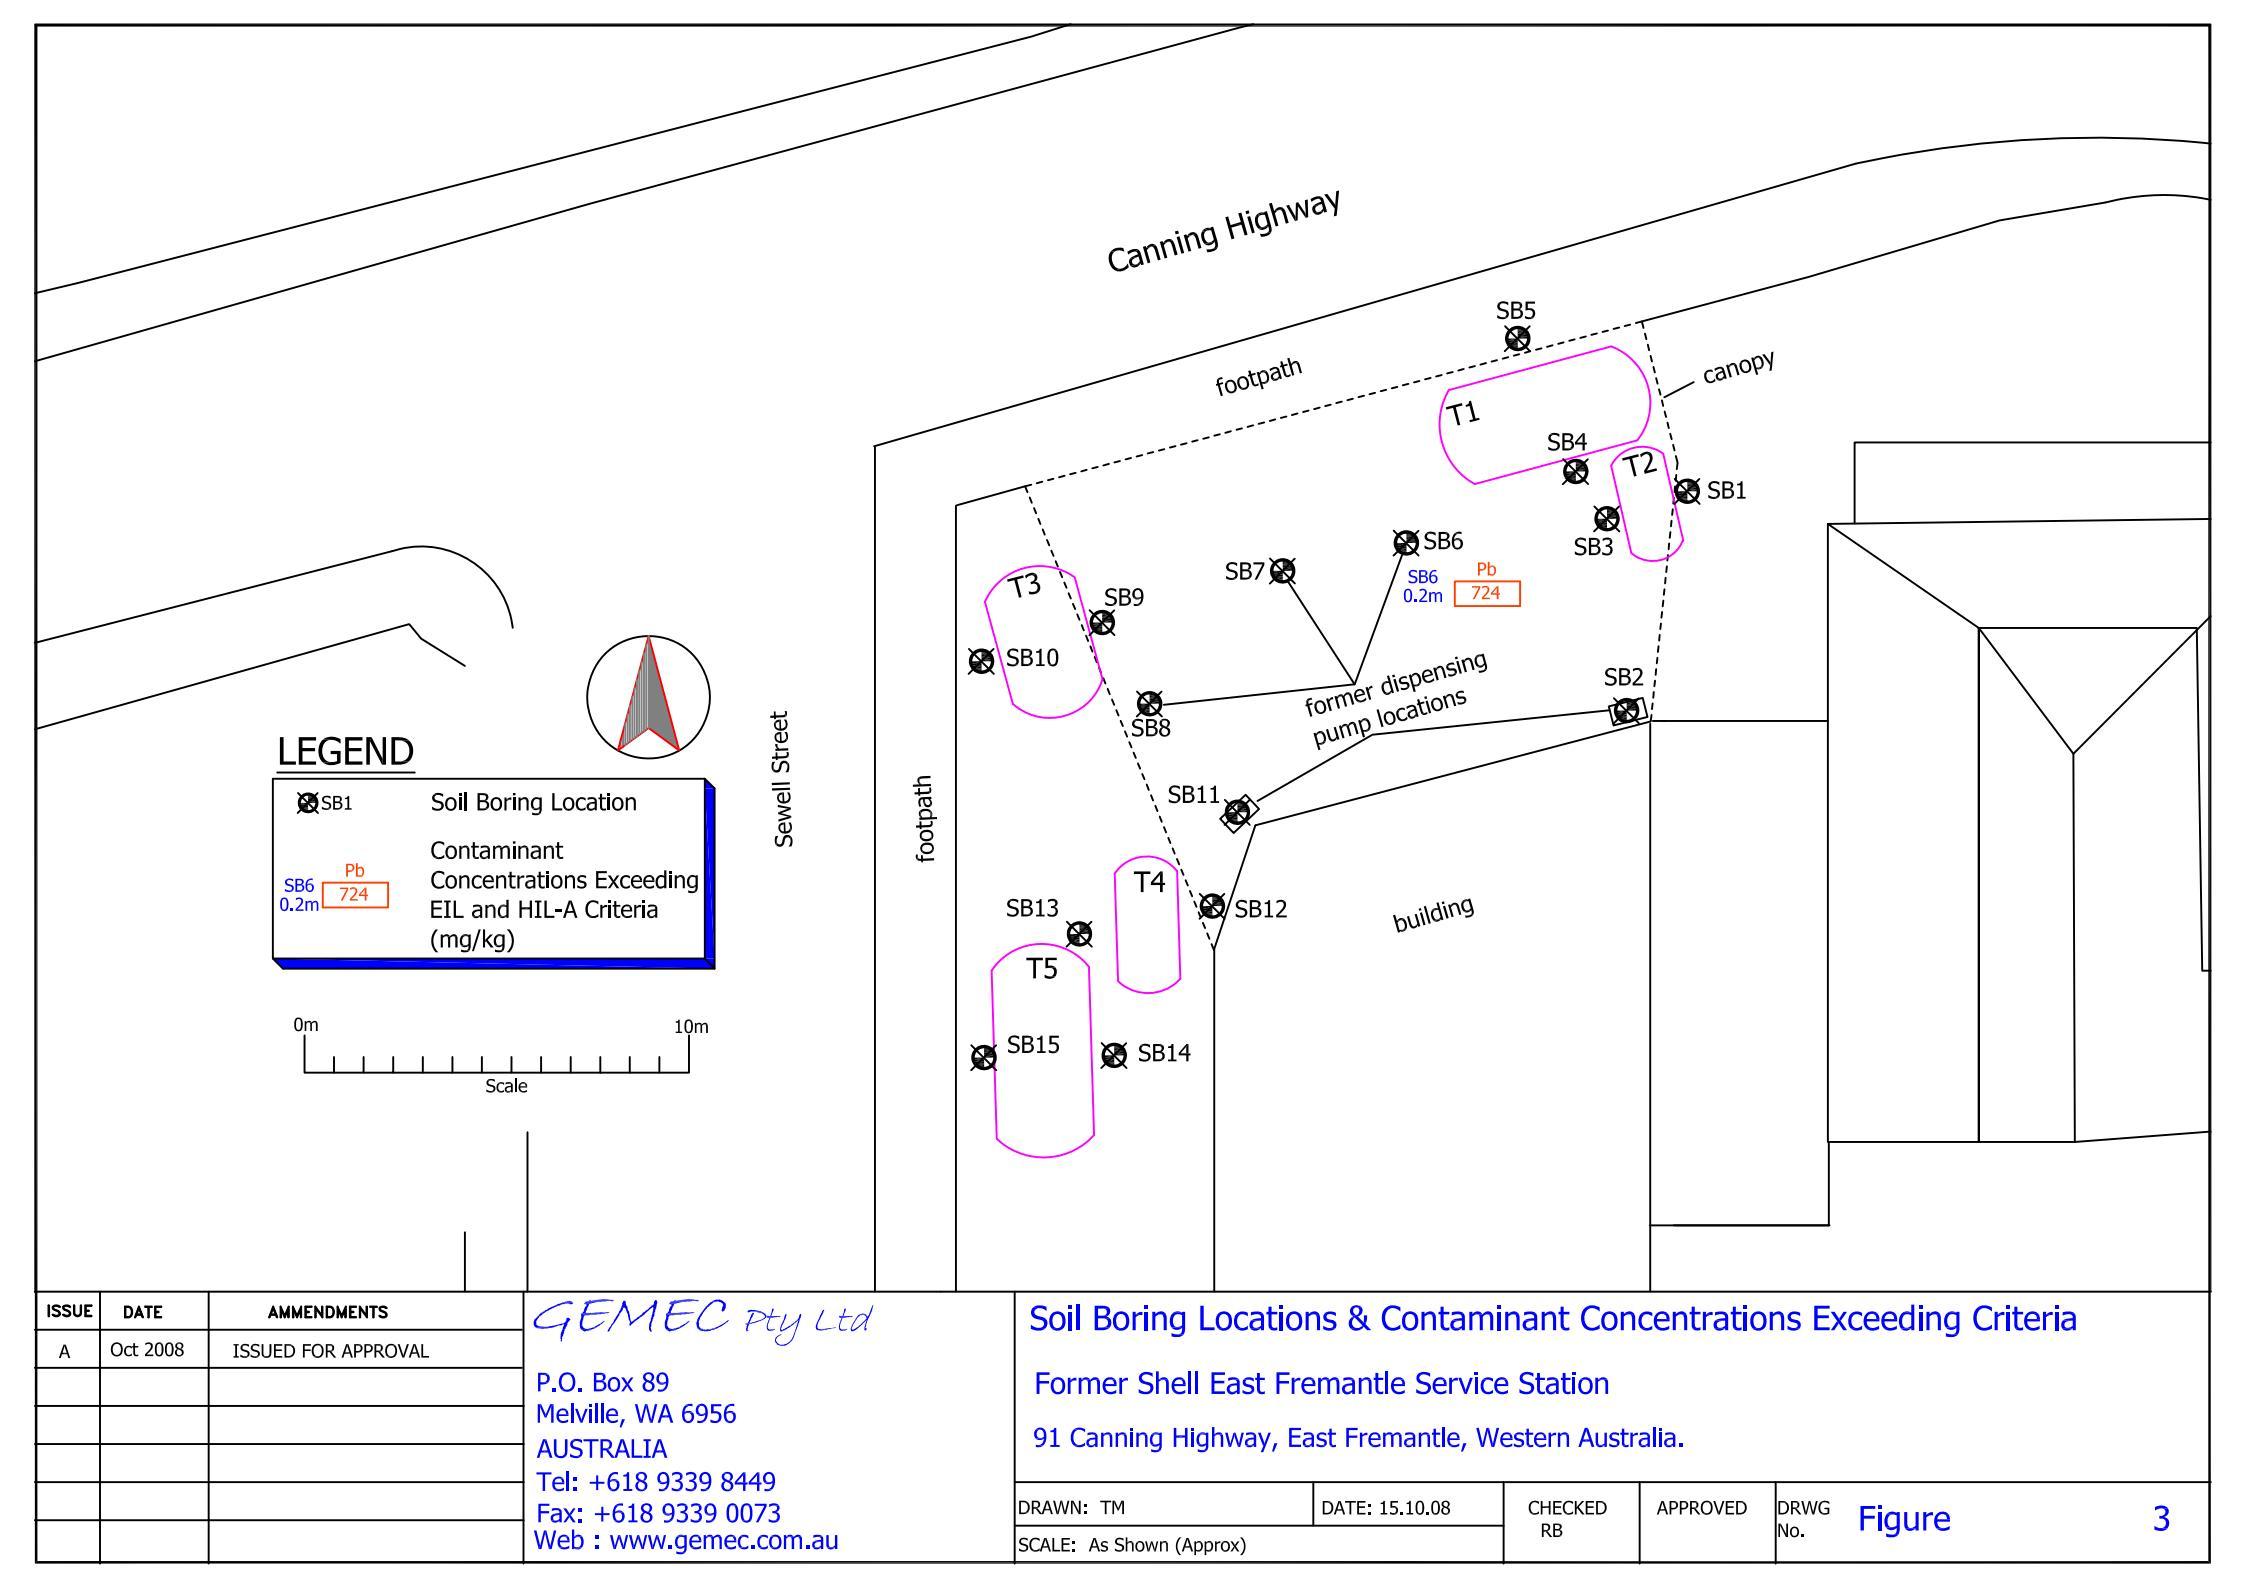
- Figure 1: Local Area Map
- Figure 1a: Aerial Photograph
- Figure 2: Site Layout and Infrastructure Locations
- Figure 3: Soil Boring Locations and Contaminant Concentrations Exceeding Criteria

No PID responses were reported in any samples collected; however weak odours and slight staining were detected in the soil at depths between 0m and $\sim 1m$ BGS for soil borings SB6 and SB8.

Significant concentrations of lead were detected in the SB6-0.2m sample, with lower concentrations detected in SB6-0.9m, SB8-1.0m, Dup1 and SB11-0.5m and minor concentrations in SB10-1.5m and SB10-3.5m. The concentration of lead found at SB6-0.2m exceeded both the EILs and the HIL-As.

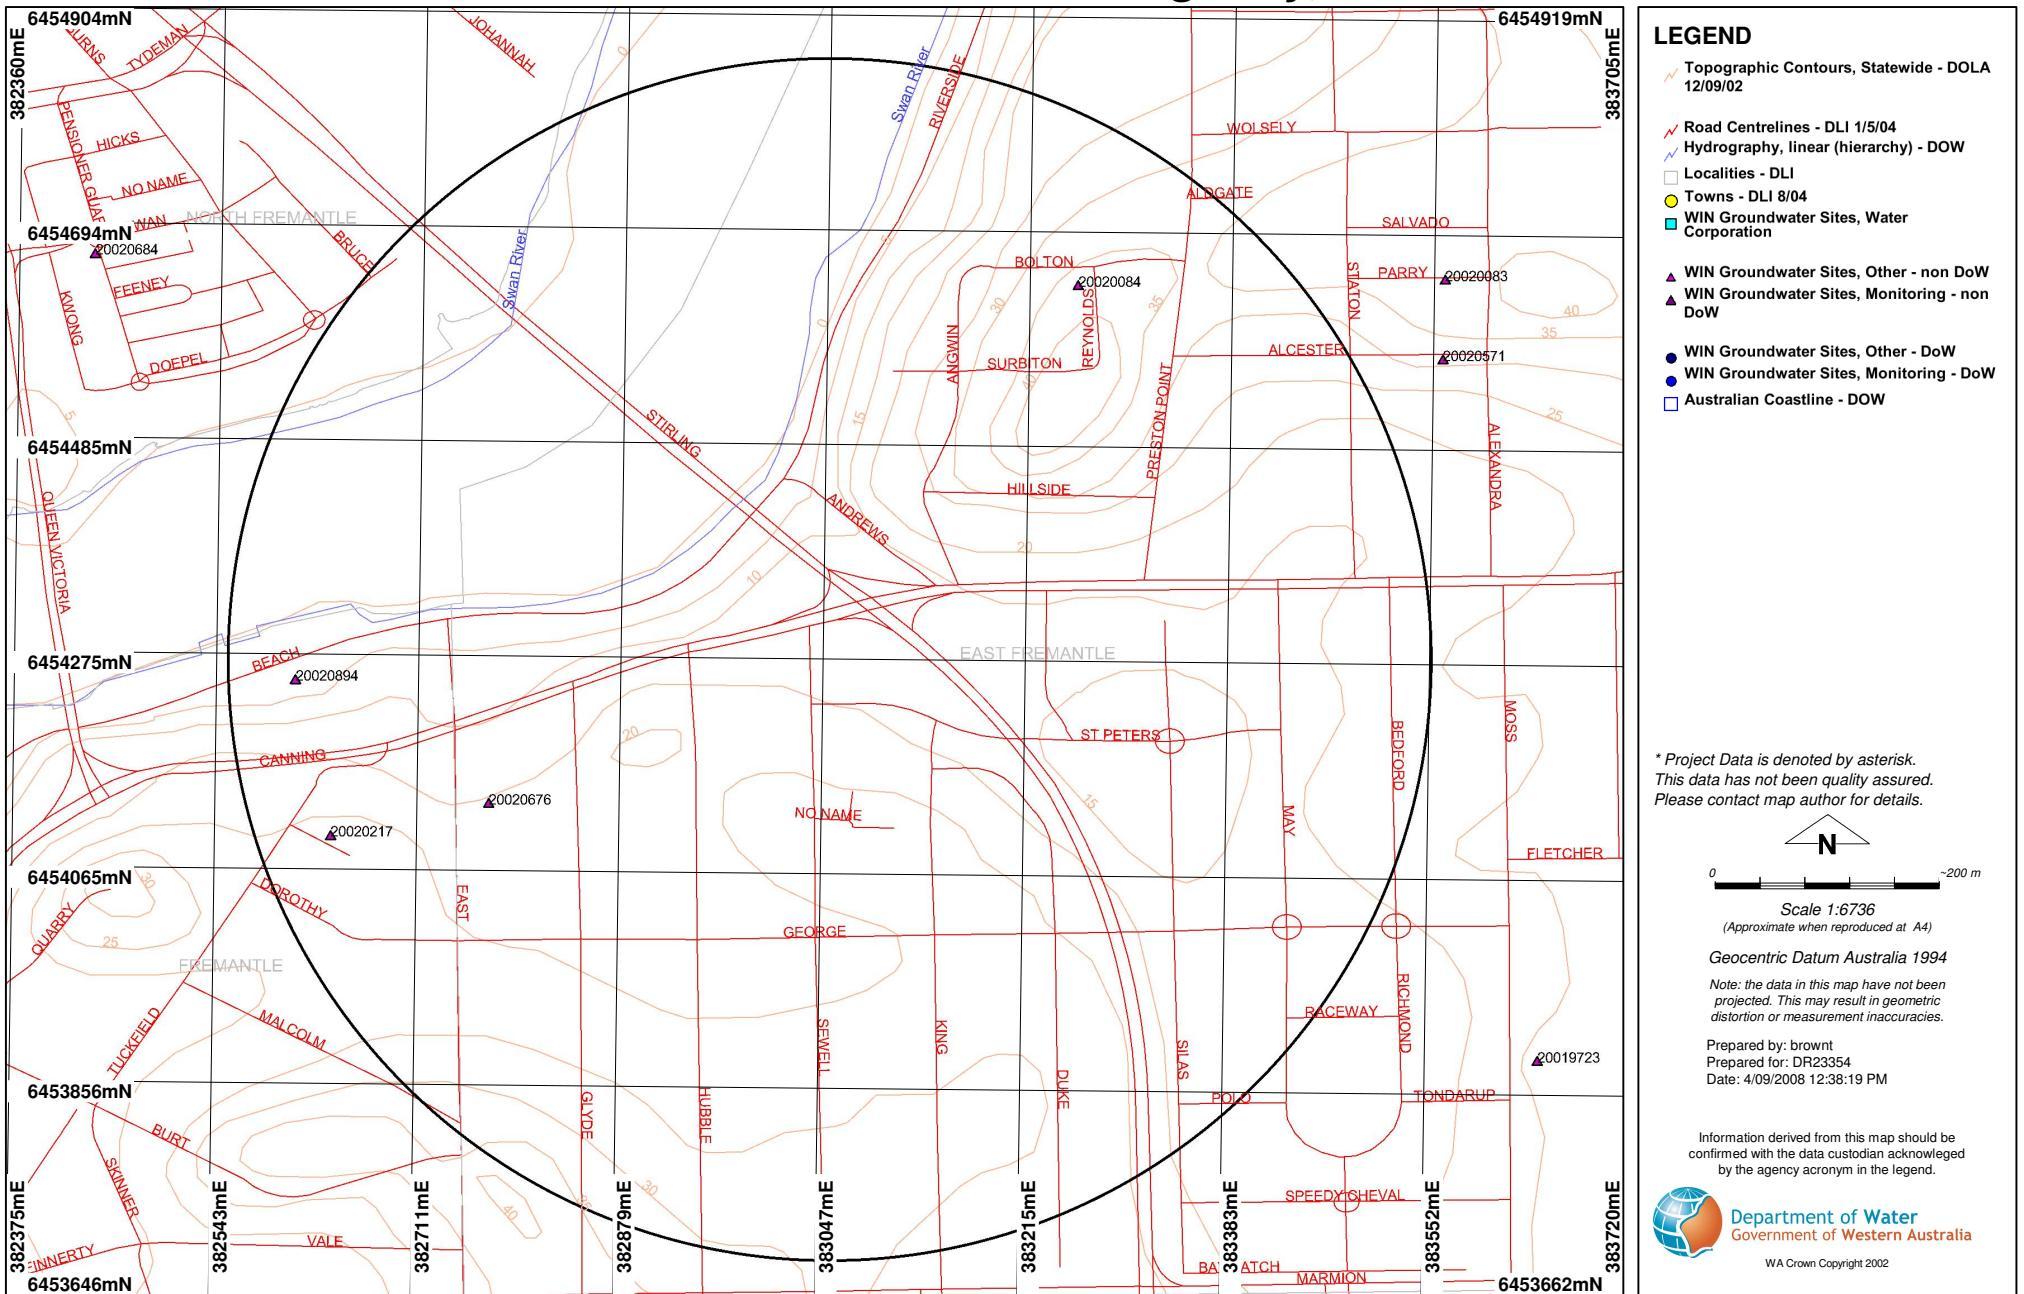
Registered Bore Data:	four groundwater extraction bores located within a 500m radius, three located \sim 300 to 400 m west south-west of the site
<u>Site Geology:</u>	fine to medium grained yellow fill sands to \sim 0.3 m BGS overlying fine to medium grain orange to brown slightly moist sand and limestone to a depth of \sim 3.5 m BGS
Depth of Groundwater:	~13.5 m BGS (Perth Groundwater Atlas)
Site Hydraulic Gradient:	unknown
Site Generic Hydraulic Conductivity:	8.2 m/d for fine to medium grain sand and 100 to 1000 m/d for Tamala Limestone (Davidson, 1995)
Site Groundwater Quality:	assumed to be fresh to marginally fresh (Perth Groundwater Atlas)

Location of bores within a 1km radius of 91 Canning Hwy, E.Fremantle

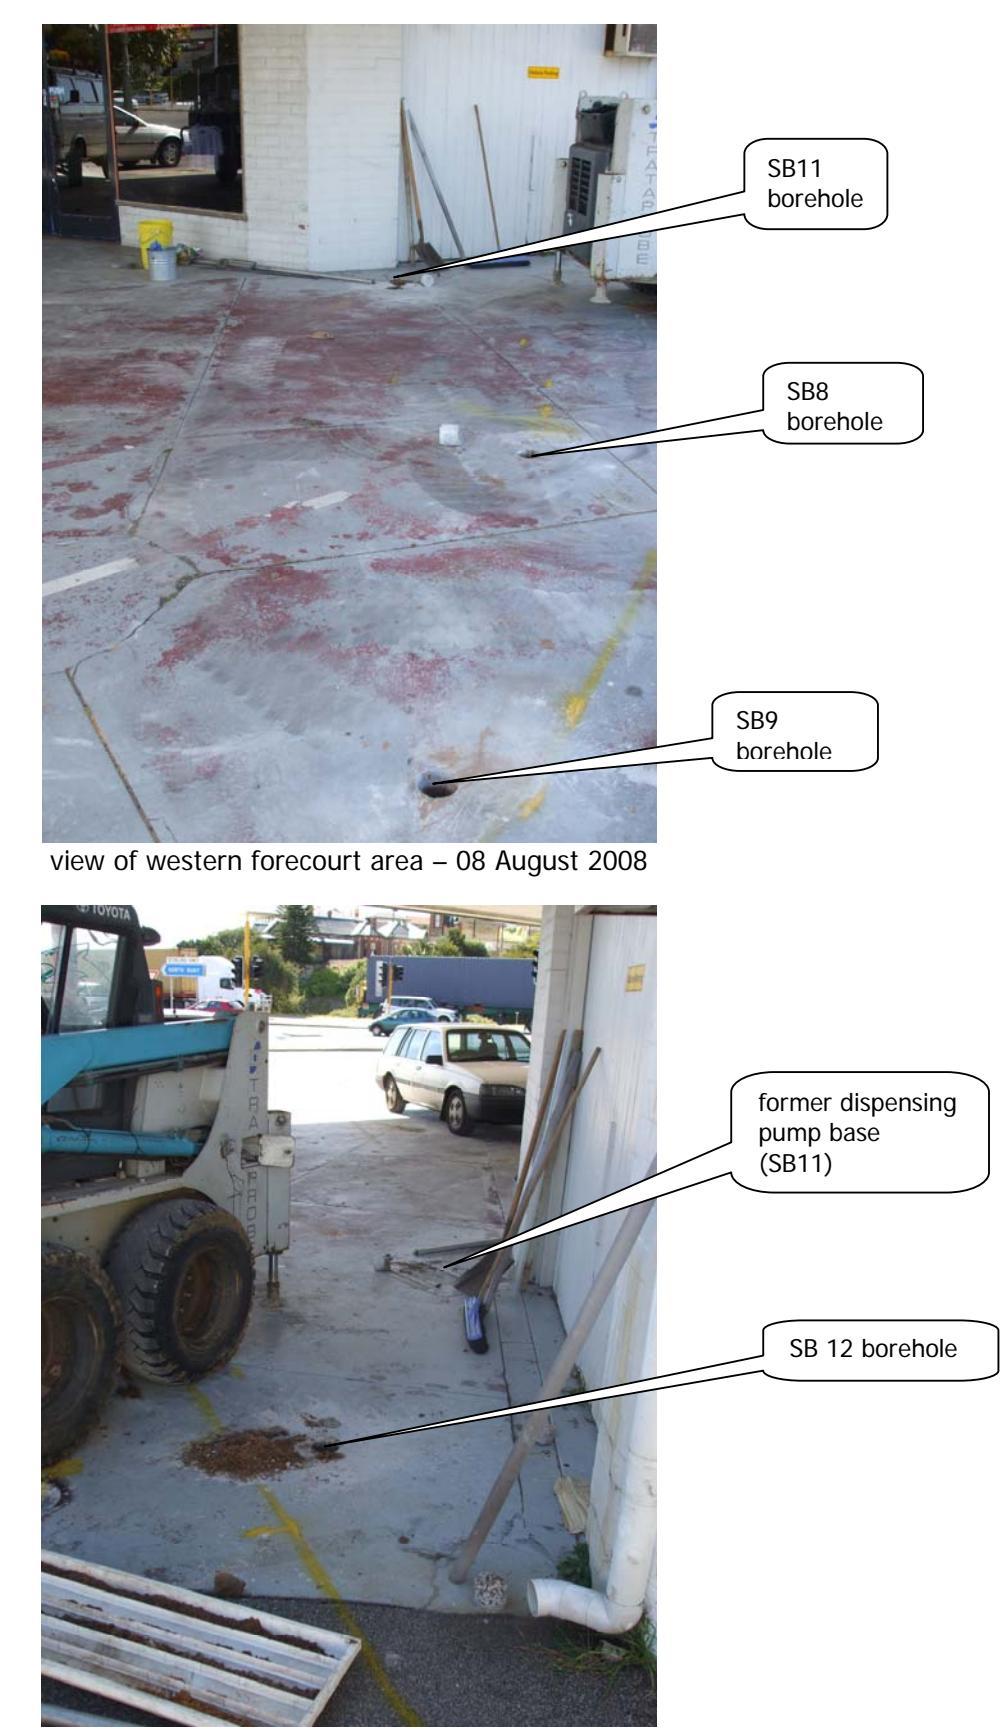
view to the north - across the former forecourt - 08 August 2008
